# 1990 Porsche 928 S4 Auto B2 Brake Band Piston Failure

This report with procedures covers the failure and repair by replacement of the B2 Brake Band Piston Assembly, the maintenance undertaken whilst access was available and the re-assembly procedure with clearance checks for a 1990 928 S4 Automatic Gear box type A28.16/Mercedes Benz 722.3 Series Automatic Transmission.

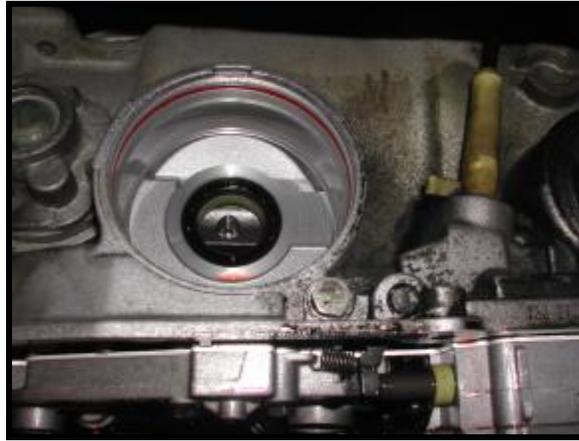
*B2 Piston aperture showing black lip seal behind which is located the plastic guide bush. The location of the thrust pin into the brake band is also visible in the centre of the hole. Also visible is the cover O-ring seal (red)*

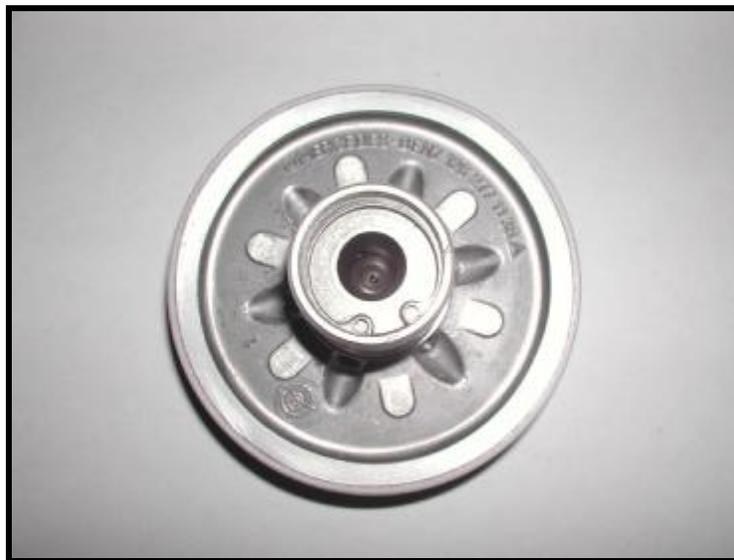
*B2 Brake Band Piston Assembly  
With a view of thimble piece and retaining circlip*

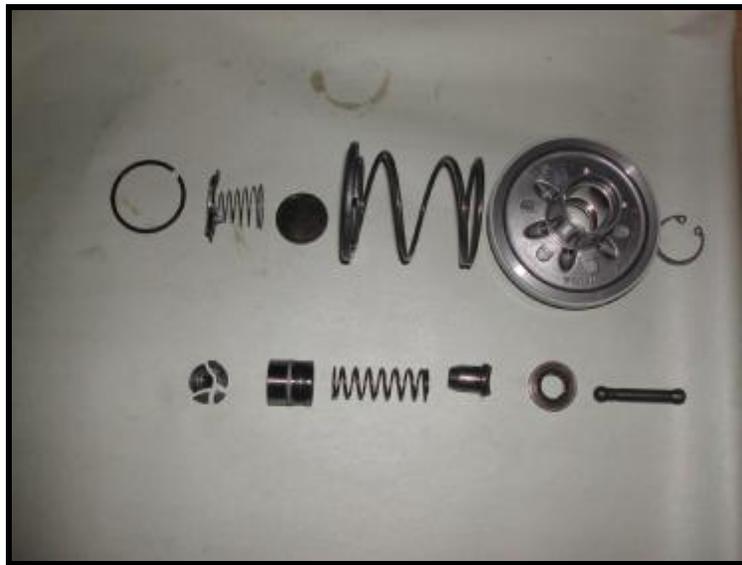
As can be seen from the picture below the inner B2 Piston crown had fractured into four pieces. It fractured circumferentially around the inside diameter of the piston. The thimble piece (no part number or name given or located in PET5) had the large diameter flange fractured off just under the flange. The inside of the cylinder liner located in the Brake Band Piston Assembly appears to be a press fit (steel cylinder liner in this case) showed a slight seizure mark about one third the circumference of the bore approximately at mid length where the piston appeared to have canted and seized. The hypothesis of the the contributing events, that led to the failure of the B2 Piston will be discussed later in this report.

*B2 Piston Assembly damage*

On examination of the parts the deduction was that the thimble piece had probably fractured first due to the binding of the small piston within the cylinder (this was indicated by the small semicircular ridge that was evident approximately half way down the cylinder).

The failure of the thimble piece allowed the lower section of the thimble to sit on the inner surface of the piston crown. Whether the B2 Piston Assembly continued to operate with this extra couple of mm clearance it is difficult to say, however, it was noted that it was taking longer to go from reverse to drive than normal, say 2 or 3 seconds or more. The small raised circular section on the inside of the piston crown was polished and this suggests that the thimble piece was riding on the inner surface of the piston crown for some time.

While the continued activation of the B2 Brake Band Piston with an operating pressure of 90psi, when changing up and down through the forward gears could have been causing an intermittent shock load to be applied to the inner surface of the piston crown, as the excess clearances was quickly taken up without any shock absorbing action. This continuous shock loading was possibly sufficient to break the piston crown out of the piston causing the total failure of the B2 Piston to operate.

The final failure possibly occasioned when the automatic transmission changed down a gear which necessitated the activation of the B2 Brake Band whilst turning a corner. Prior to the failure a slight slippage was detected and then complete failure of all forward gears. Maybe at this juncture the final failure of the piston crown removed all force from being applied by the thrust pin to apply the B2 Brake Band.

It was decided to renew the B2 Brake Band Piston Assembly, as a total replacement unit, to renew the Cover Plate O-ring seal as well as the lip seal item 7, part number 006 997 734 7, as shown in PET5 illustration number 307-55. To renew the seal it necessitated driving the bush and seal out from the inside the transmission case.

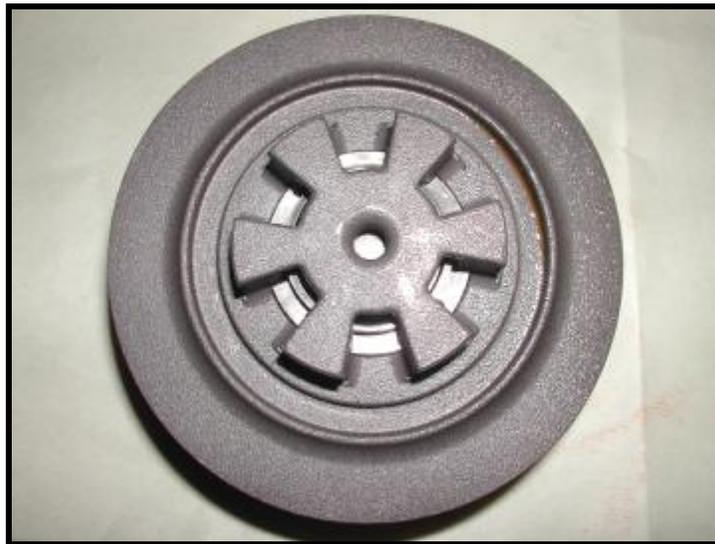
*B2 Piston Old model Piston Assembly  
appears to be cast iron*

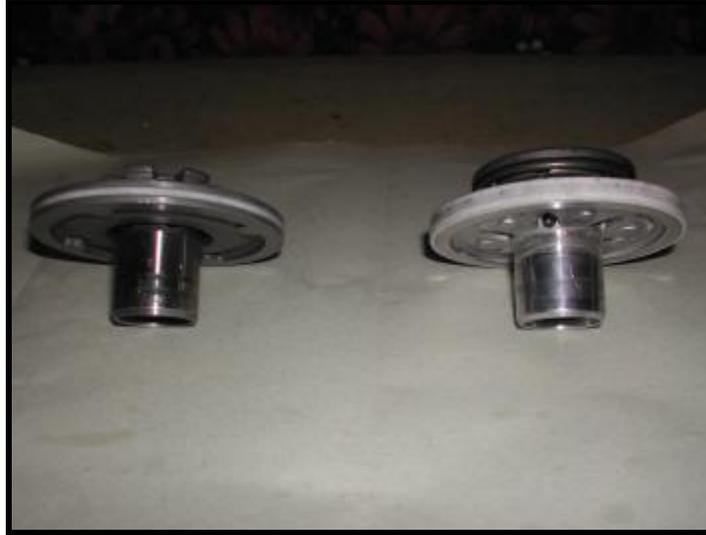
*Old B2 Piston Assembly on LHS & Modified B2Piston Assembly on RHS*

The old model B2 Brake Band Piston Assembly appears to be a cast iron assembly and it can be noted that the plastic type sealing ring is very similar to a piston ring (rectangular cross section). It was reported that the Brake band Piston Assembly was redesigned in the late 80s into a more robust unit and manufactured from aluminum. This seal ring was reportedly modified by MB in the late 1993/4 into a “T” shaped seal ring and the cylinder liner was modified to a plastic material replacing the steel liner. Both these modifications were reported to have been made to reduce the instances of seizure/binding due to canting of the outer and inner pistons and to reduce bore wear which could increase the instance of binding.

It will be noted from the photograph above that the B2 Brake Band Piston Assembly as removed from the vehicle had the more robust aluminum assembly, it was fitted with the “T” seal ring, however, it still had the steel cylinder liner fitted for the thrust pin actuating piston.

Richard recommends that any pre-1994 MB should be fitted with the new version of the B2 Brake Band Piston Assembly with the above mentioned modifications as a preventative maintenance precaution. No recommendations are made or inferred by this report. The report covers what was done when the transmission was opened up for investigation of the failure and the repairs and maintenance carried out to return the AT to good working condition.

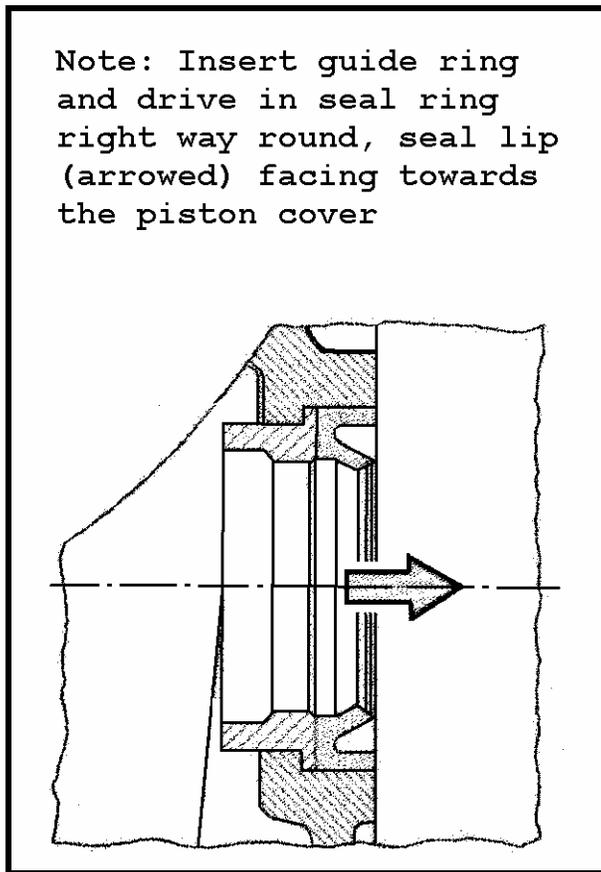
PET5 illustration 307-55 shows an incorrect location of items 6 & 7, the bush (Part Number 126 277 085 0) is installed after item 7 sealing ring (Part Number 006 997 734 7) when in fact it is the opposite as shown in the WSM Page 37-153 where the illustration below clearly shows the bush is installed first and the sealing ring in the top of the bush with the lip seal facing towards the B2 Piston Assembly Cover. This is because the pressure within the B2 Piston cylinder is approximately 90psi when the B2 Brake is applied. If this seal is installed with the lip seal toward the internals of the transmission the ATF could bypass the lip seal and the Piston could fail to activate the B2 Brake Band, which could cause the same failure of no forward motion in any of the forward gears.

*Sketch of location of bush and lip seal facing outwards towards piston cover*

1. Replaced the B2 piston bush in the transmission case - a hand push fit - and installed the lip seal with the lip facing outwards. Installation was by applying ATF to the outside diameter of the seal and driving it home using a suitable diameter socket and hammer. A proper mandrel, as shown in the Porsche Special Tools in the AT section of the WSM, could have been machined on the lathe, but the socket was considered sufficient for this one-off installation.

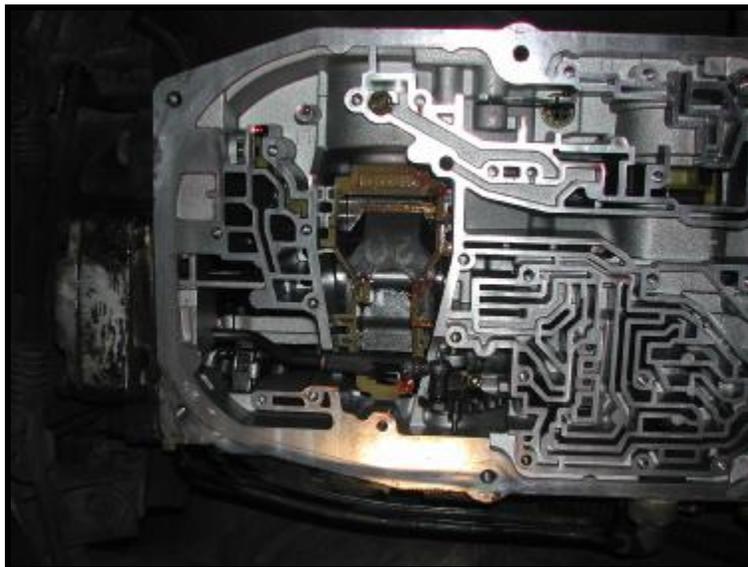
*Transmission with Valve Body, (Lower Cover & Intermediate Plate removed) showing Brake Guide and B2 Brake Band  
The leaf spring set bolt hole and locating pin hole can be seen adjacent to the lower transmission case edge, to the upper left of the flash reflection*

Inspected brake band and outside diameter of clutch housing and there was no noticeable wear to the brake band or cylinder. As a matter of fact the original machining marks on the clutch housing OD were still visible. All appeared in excellent condition and there was no discolourisation or burn marks on the clutch cylinder, no wear particles at the edge of the brake band or any sign of this type of debris in the oil pan.
