Porsche 928 S4 A28 16 type Automatic Transmission – Oil Pan Gasket DIY Alert dated March 2005

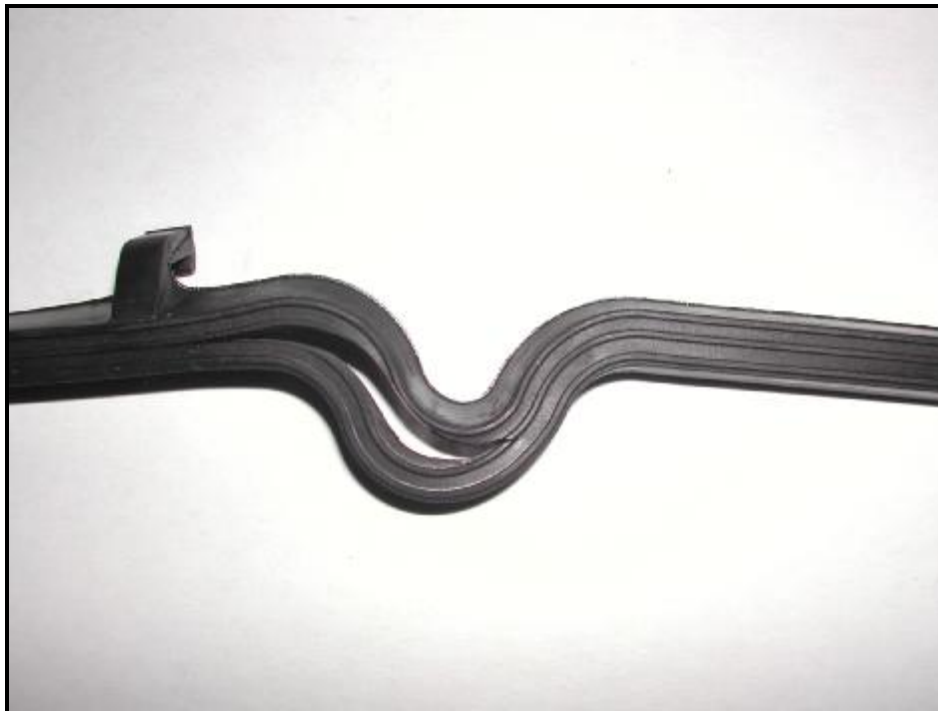
Initial inspection showed that the ATF was leaking out of the top of the gasket just forward of the RHS centre set bolt. On close inspection it was noted that the top surface of the oil pan gasket had extruded wider than the landing surface of the gear box casing.

Photograph of RHS of Oil Pan Gasket showing split

The gasket had split on the R and LHSs adjacent of the centre set bolt locations. The leakage came from the RHS, as the split was approximately 3.5 cm long. It crossed over the centre rib of the seal surface (the gasket has three ribs located on the upper surface where it abuts the landing face of the gear casing as can be seen in the above photograph). The inner and the outside rib remained intact. It was assumed that the gasket extruded sufficiently to loose the inner and out rib seal on the landing surface and the ATF leaked through the split centre rib and out the extruded area near the gasket location piece.

Inspection the old gasket revealed it was still in good condition and it had only been fitted to the gear box for approximately 8,000 kms and for around 15 months previously, so a decision was made to fit the old gasket as a gasket was not available for over a week due to the Easter Holiday and my wife's car was being serviced.

Again the set bolts of the oil pan were tensioned up to the 8 Nm in small increments, the ATF replaced and the engine run and gearbox filled as per Porsche's specifications.

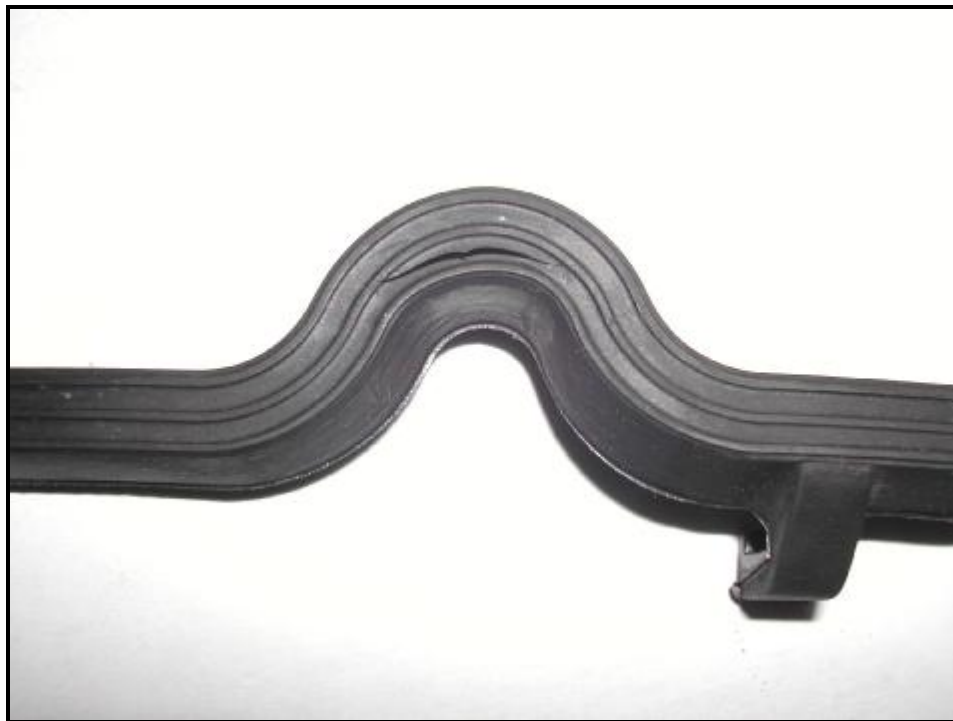
The LHS split was parallel to the ribs and did not cross over the centre rib, so the centre rib made a seal.

Photograph of LHS of oil pan gasket showing smaller split

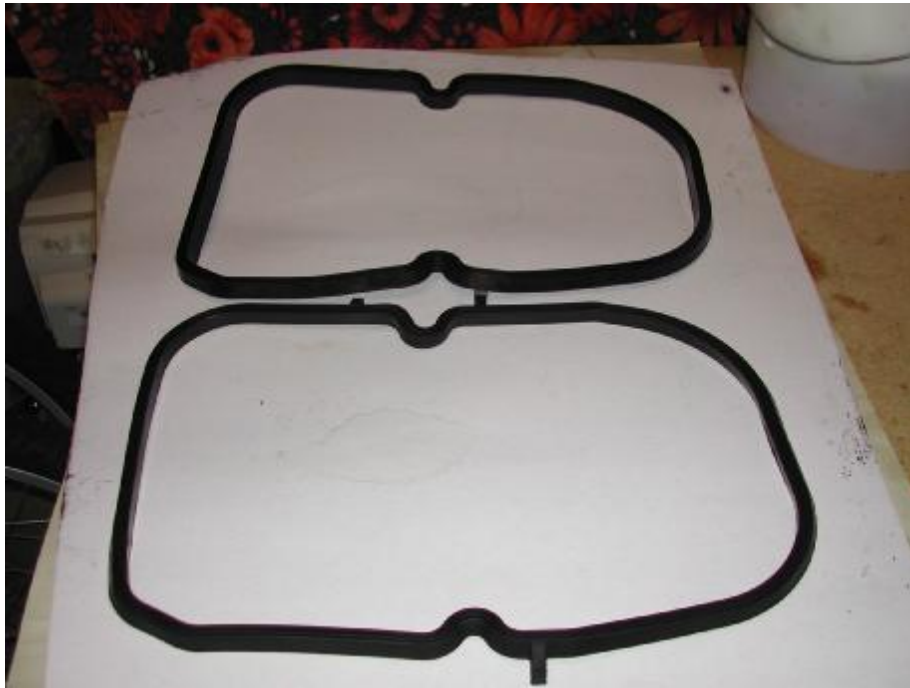
Please note that MB had problems with the 126 271 10 80 oil pan gasket splitting along the side lengths prior to the September 1994 and the fix was to replace the gasket with a modified one part number 126 271 11 80 in 1994, however Porsche was still supplying the 126 271 10 80 gaskets up to at least 2002 and my local PC has been supplying these in the Service Kits up until the present. The old pan gasket was supplied in 2003 and new on in March 2005.

At the meeting he viewed the failed gasket, the MB Administrative Message and he offered to supply a new 126 271 11 80 gasket. On inspection of this 11 80 gasket it is a more robust gasket and thicker, hopefully to prevent the splitting and the lower inner face that fits over the oil pan is deeper than the 10 80 gasket. This may be to stop the rolling inwards at the forward corners.

Photograph of fail Oil Pan Gasket in foreground and new 1180 more substantial gasket at the rear.

The current proposal is to run the car with the existing 10 80 old design gasket and see whether it fails. If it does not fail it will be left in situ, however if it starts to leak it will change it out for the modified 11 80 gasket.

The ALERT is: be sure that if you obtain an Automatic Transmission Service Kit it contains the modified 11 80 gasket or if you order a gasket by itself it is the 11 80 type oil pan gasket.
