## **Porsche 928 S4 A28 16 type Automatic Transmission – Oil Pan Gasket DIY Alert dated March 2005**

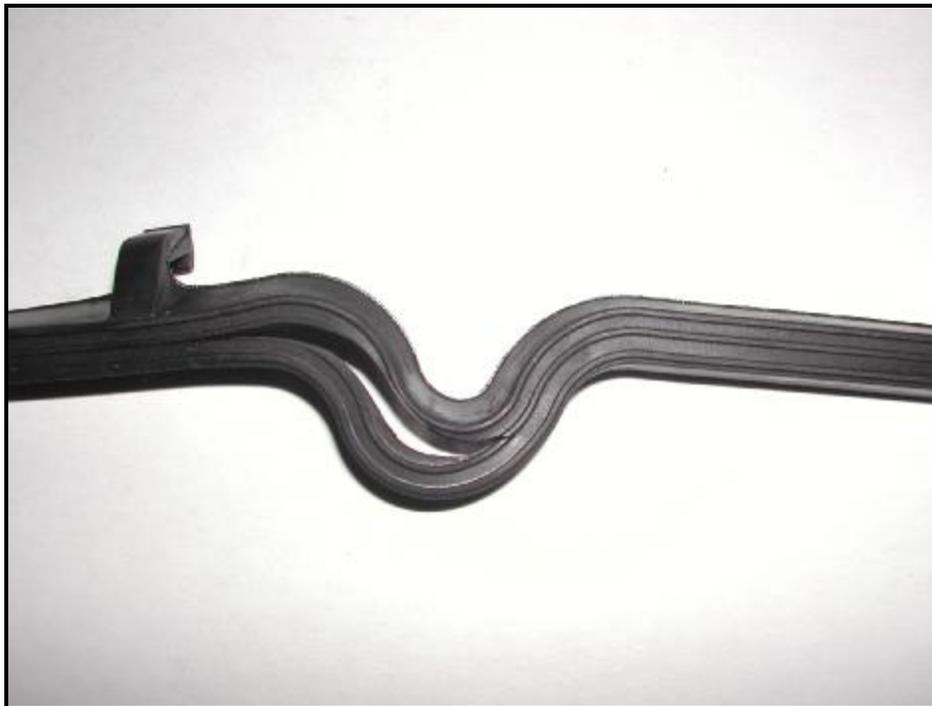
Initial inspection showed that the ATF was leaking out of the top of the gasket just forward of the RHS centre set bolt. On close inspection it was noted that the top surface of the oil pan gasket had extruded wider than the landing surface of the gear box casing.

*Photograph of RHS of Oil Pan Gasket showing split*

The gasket had split on the R and LHSs adjacent of the centre set bolt locations. The leakage came from the RHS, as the split was approximately 3.5 cm long. It crossed over the centre rib of the seal surface (the gasket has three ribs located on the upper surface where it abuts the landing face of the gear casing as can be seen in the above photograph). The inner and the outside rib remained intact. It was assumed that the gasket extruded sufficiently to loose the inner and out rib seal on the landing surface and the ATF leaked through the split centre rib and out the extruded area near the gasket location piece.

**Remedy:**  
Replace transmission oil pan gasket. Refer to Parts Information listed below.  
Transmission oil pan bolt tightening torque: 8 Nm

**The ALERT is: be sure that if you obtain an Automatic Transmission Service Kit it contains the modified 11 80 gasket or if you order a gasket by itself it is the 11 80 type oil pan gasket.**

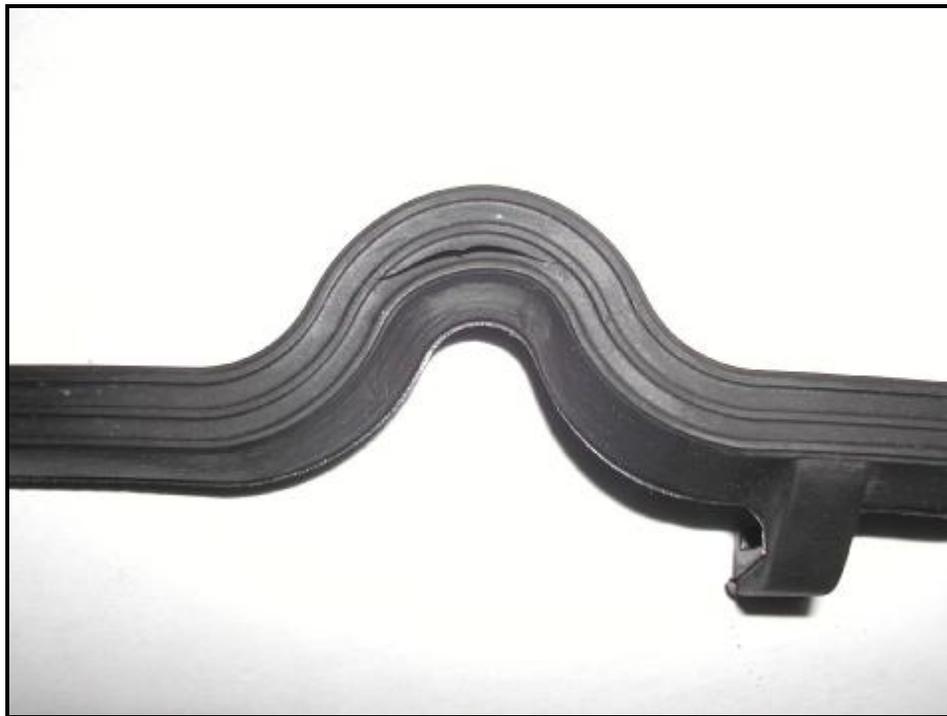
The LHS split was parallel to the ribs and did not cross over the centre rib, so the centre rib made a seal.

*Photograph of LHS of oil pan gasket showing smaller split*

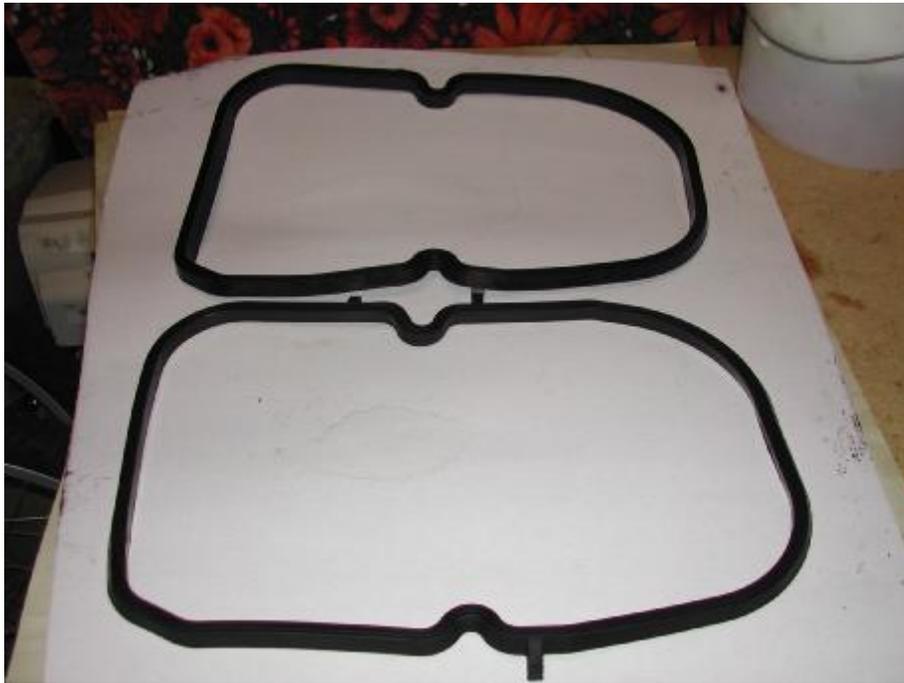
Please note that MB had problems with the 126 271 10 80 oil pan gasket splitting along the side lengths prior to the September 1994 and the fix was to replace the gasket with a modified one part number 126 271 11 80 in 1994, however Porsche was still supplying the 126 271 10 80 gaskets up to at least 2002 and my local PC has been supplying these in the Service Kits up until the present. The old pan gasket was supplied in 2003 and new on in March 2005.

At the meeting he viewed the failed gasket, the MB Administrative Message and he offered to supply a new 126 271 11 80 gasket. On inspection of this 11 80 gasket it is a more robust gasket and thicker, hopefully to prevent the splitting and the lower inner face that fits over the oil pan is deeper than the 10 80 gasket. This may be to stop the rolling inwards at the forward corners.

*Photograph of fail Oil Pan Gasket in foreground and new 1180 more substantial gasket at the rear.*

The current proposal is to run the car with the existing 10 80 old design gasket and see whether it fails. If it does not fail it will be left in situ, however if it starts to leak it will change it out for the modified 11 80 gasket.
