# Technical Bulletin

Model  
928 S4

**Subject:** Broken Central Tube Shaft  
Vehicles with Automatic Transmission

Number  
9206

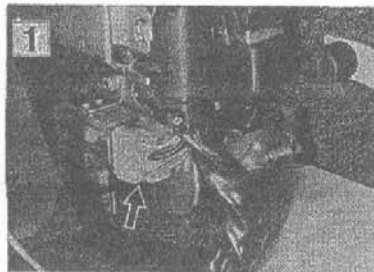
Figure 1

2. Replace the left side ignition coil wire with the part number listed in this bulletin. Be certain the coil wire is routed freely and not under tension.
3. Check all ignition components and connectors for corrosion, tightness, correct connection and damage. Repair or replace as necessary. If an ignition circuit has malfunctioned, an LED indication will be given by the ignition monitor relay located on the L-H control unit mounting plate (Figure 1).

Ignition circuit I (cyl. 1-7-6-4) Red diode  
Ignition circuit II (cyl. 3-2-5-8) Green diode

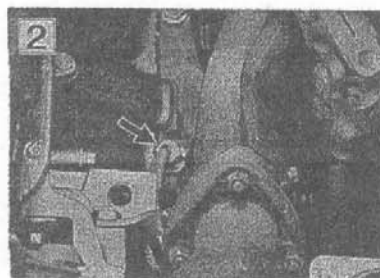
Figure 2

4. Replace both temperature sensors (Figure 2) located in the exhaust ports:

Model '89-'90, cyl. 4 and 8

Model '91 cyl. 3 and 7

Use the new version temperature sensors listed in this bulletin.

When installing temperature sensors, coat the sensor adapter threads with molykote paste HTP (white) and torque sensors to 10Nm.
