Porsche 928 Window Regulator

Rich Andrade July 2022

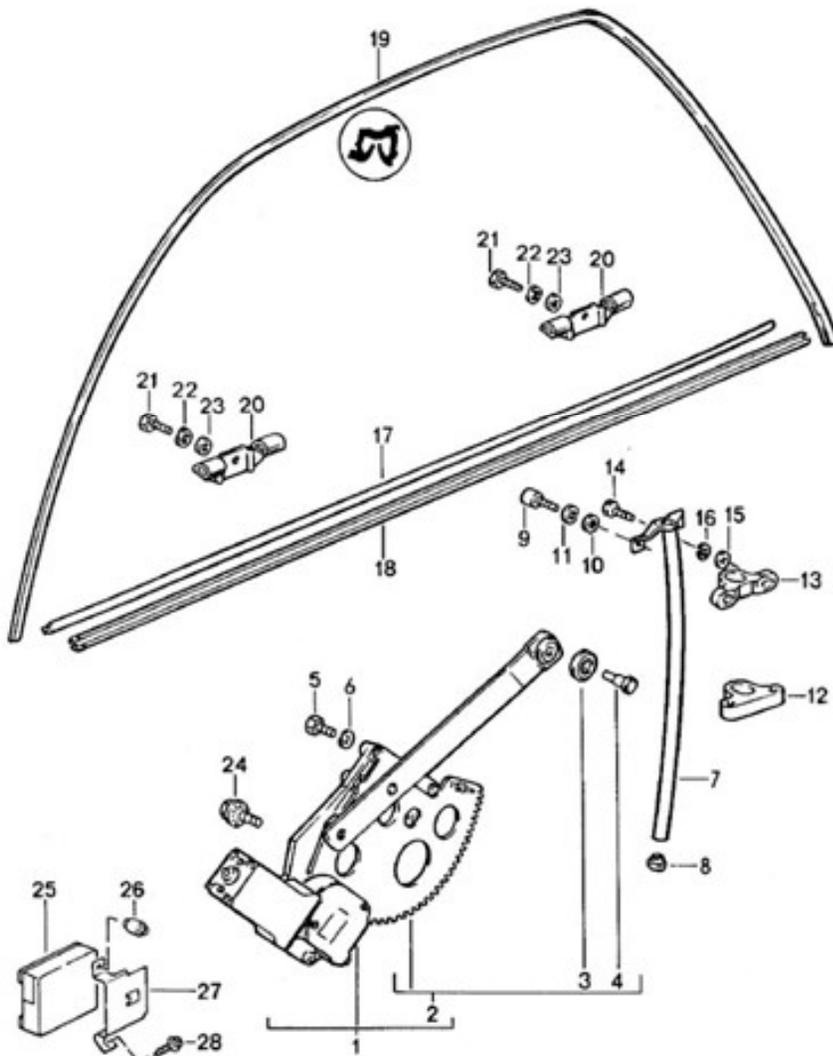
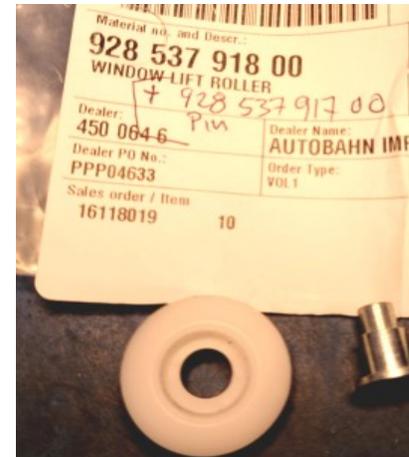
The passenger side window on my 1979 928 fell all the way down. When this happens, it is due to the plastic regulator roller breaking. The roller is item #3 in the diagram to the left.

Roller is Item # 3 P/N: 928 537 918 00

Roller Bolt is item # 4 P/N: 928 537 917 00

However, the roller bolt is not threaded, it is pressed into place and has to be grinded out and Hammer pressed back into place. It is easy to damage the roller during this job. Caution must be exercised.

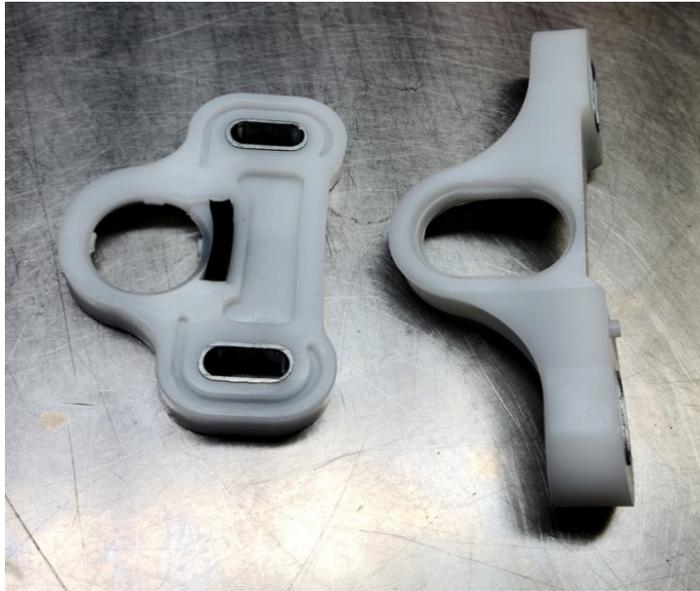
Lower slide left, upper slide right

Left Lower Slide is #12 P/N: 928 537 259 02
Right Lower Slide #(12) P/N: 928 537 260 02

Left Upper Slide #13 P/N: 928 537 289 02
Right Upper Slide #(13) P/N: 928 537 290 02

While repairing the window regulator, you may as well replace the upper and lower slides that hold the window in place on the support rod.

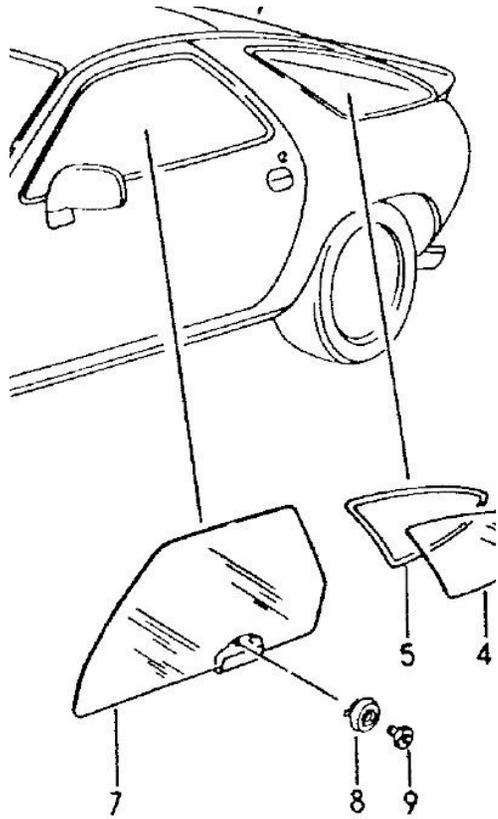
I had further complications; there are two bolts that fit through the upper slide that connects to the base of the window. The associated nuts are held into place on the window base towards the outside of the car by a plastic cap. The two caps broke so the bolts would not come loose. My mechanic had to cut apart the upper slide to gain access to remove the bolts – it wasn't easy. The parts catalog lists the nut and cap in the diagram to the left.

Fastening plug #8 P/N: 928 537 281 04

Threaded piece (nut) #9 P/N: 928 537 277 02

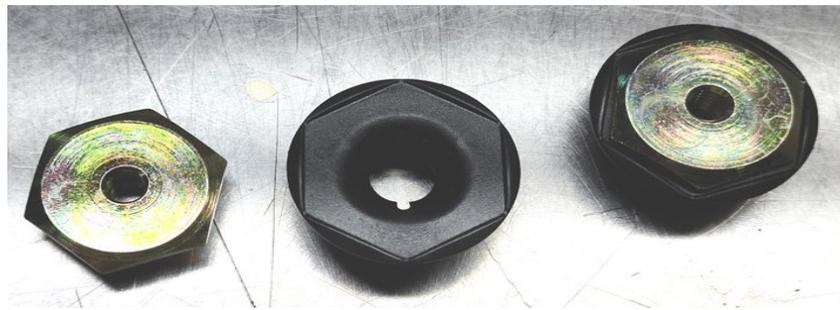
“Threaded piece” left, fastening plug (cap) center and threaded piece (nut) inserted into cap right

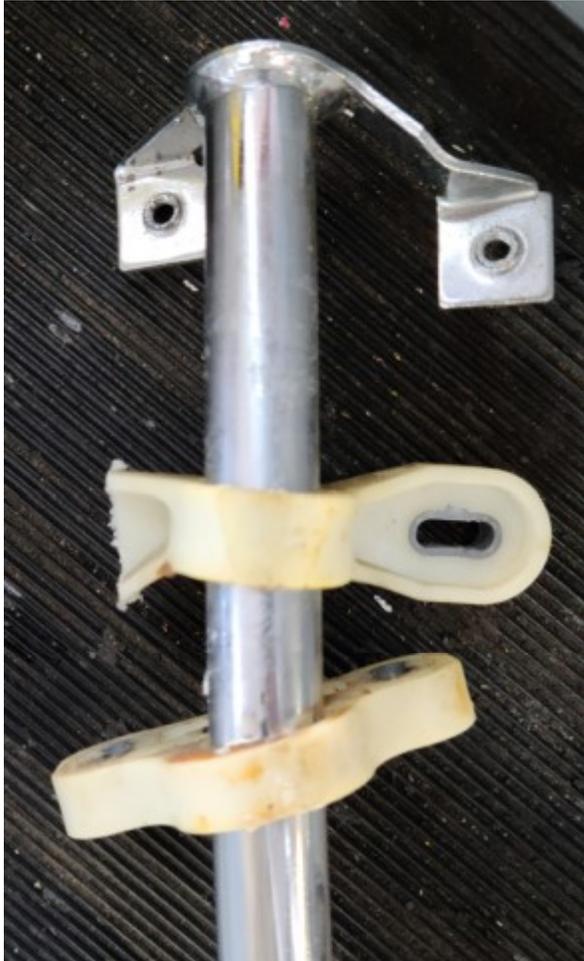
The complications took quite some work to overcome. The photo above shows the upper slide, the left portion had to be cut off to enable access to the bolt that couldn't be unscrewed.

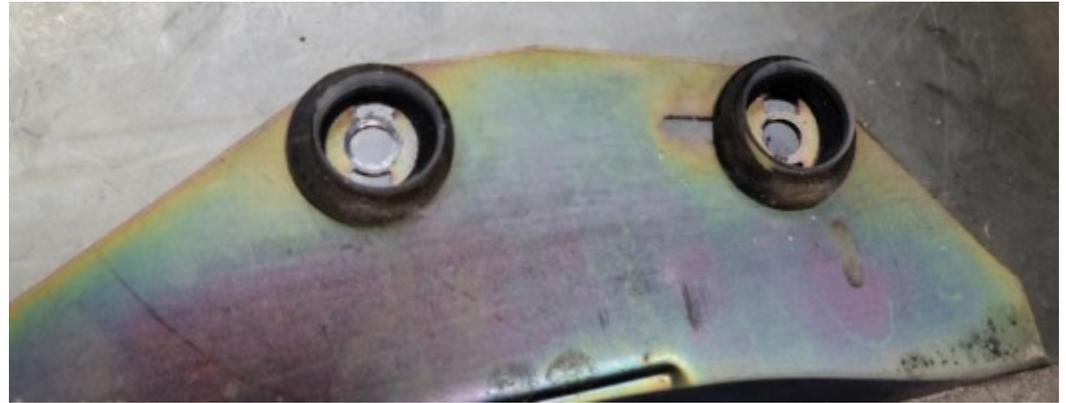
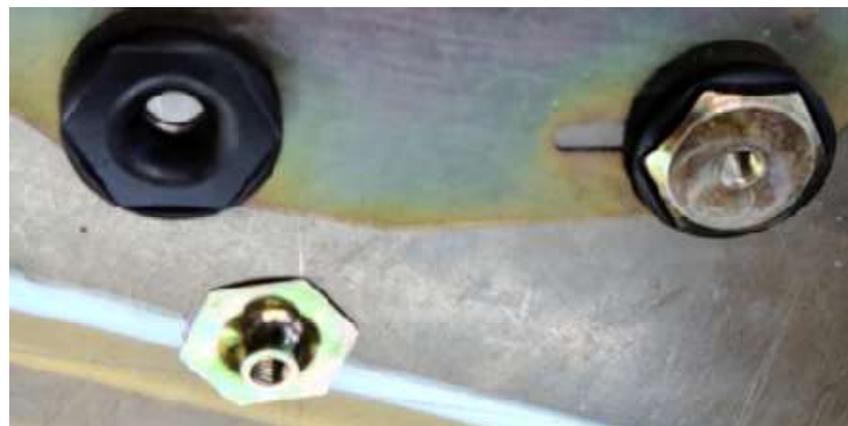
Above is the side of the window to the outside of the door with cap and nut removed, below is the Window with the nut and cap installed.
