REAR MAIN SEAL REPLACEMENT WITH THE TRANSMISSION LEFT IN PLACE

Simplified Procedure for 89 S4 Automatic

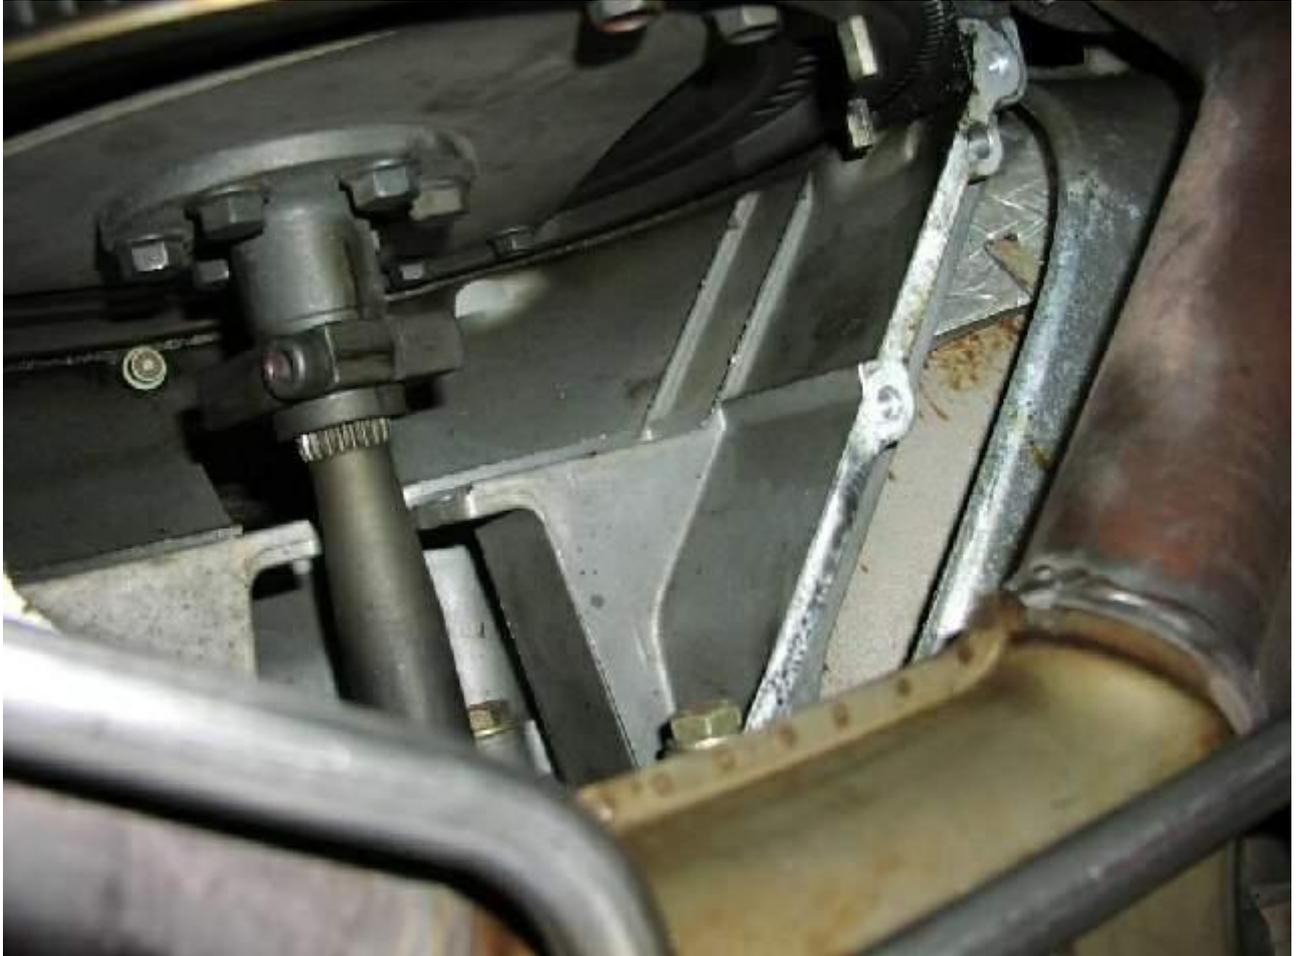
Here is the view (exhaust loosened but left in place in early photos). Many think the TT

central shaft obstructs flexplate removal. Let's see.

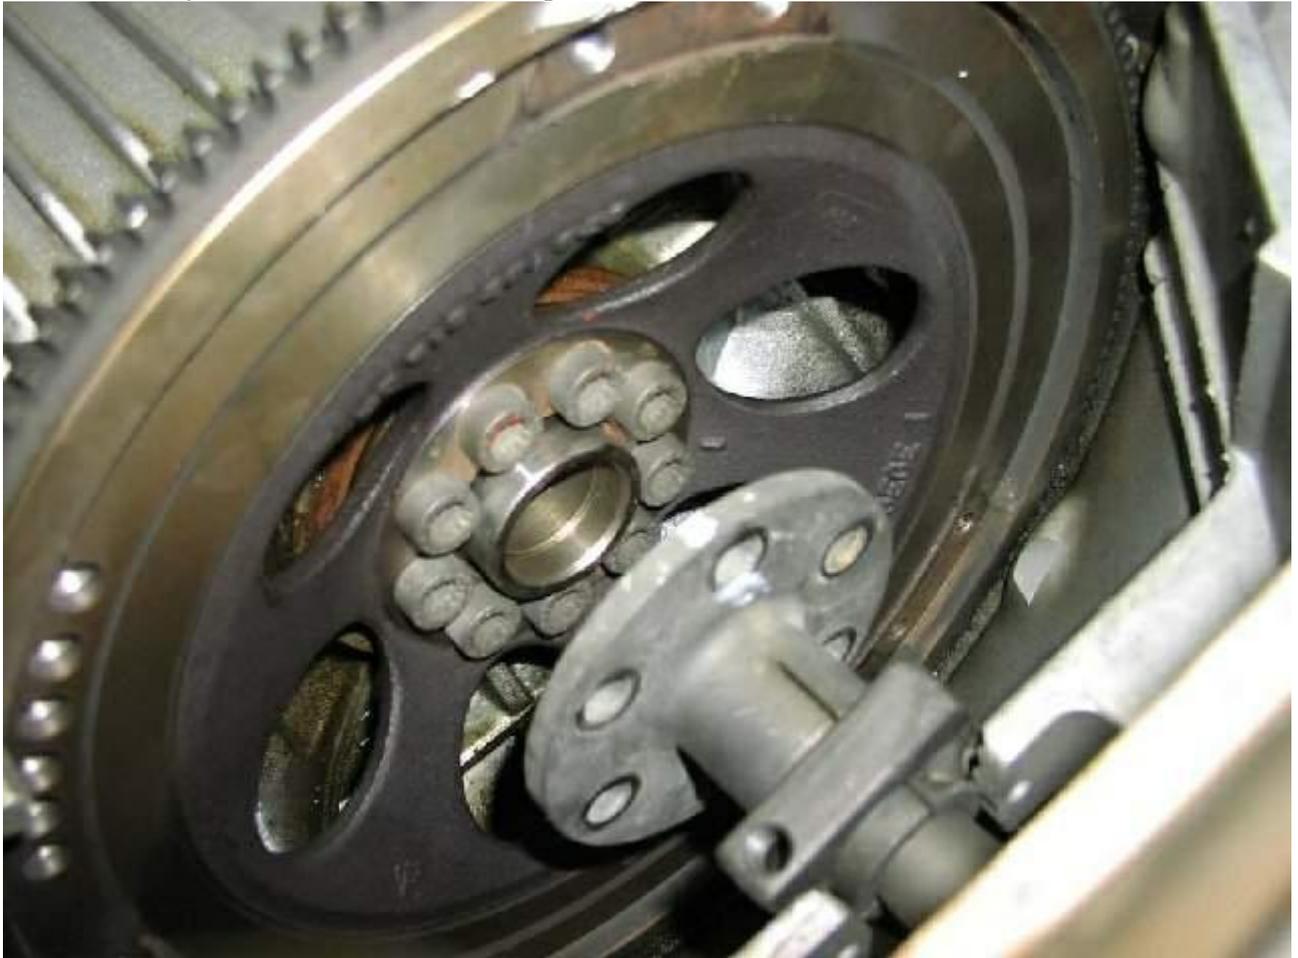
Observe the flywheel cheesehead bolts in plain view.

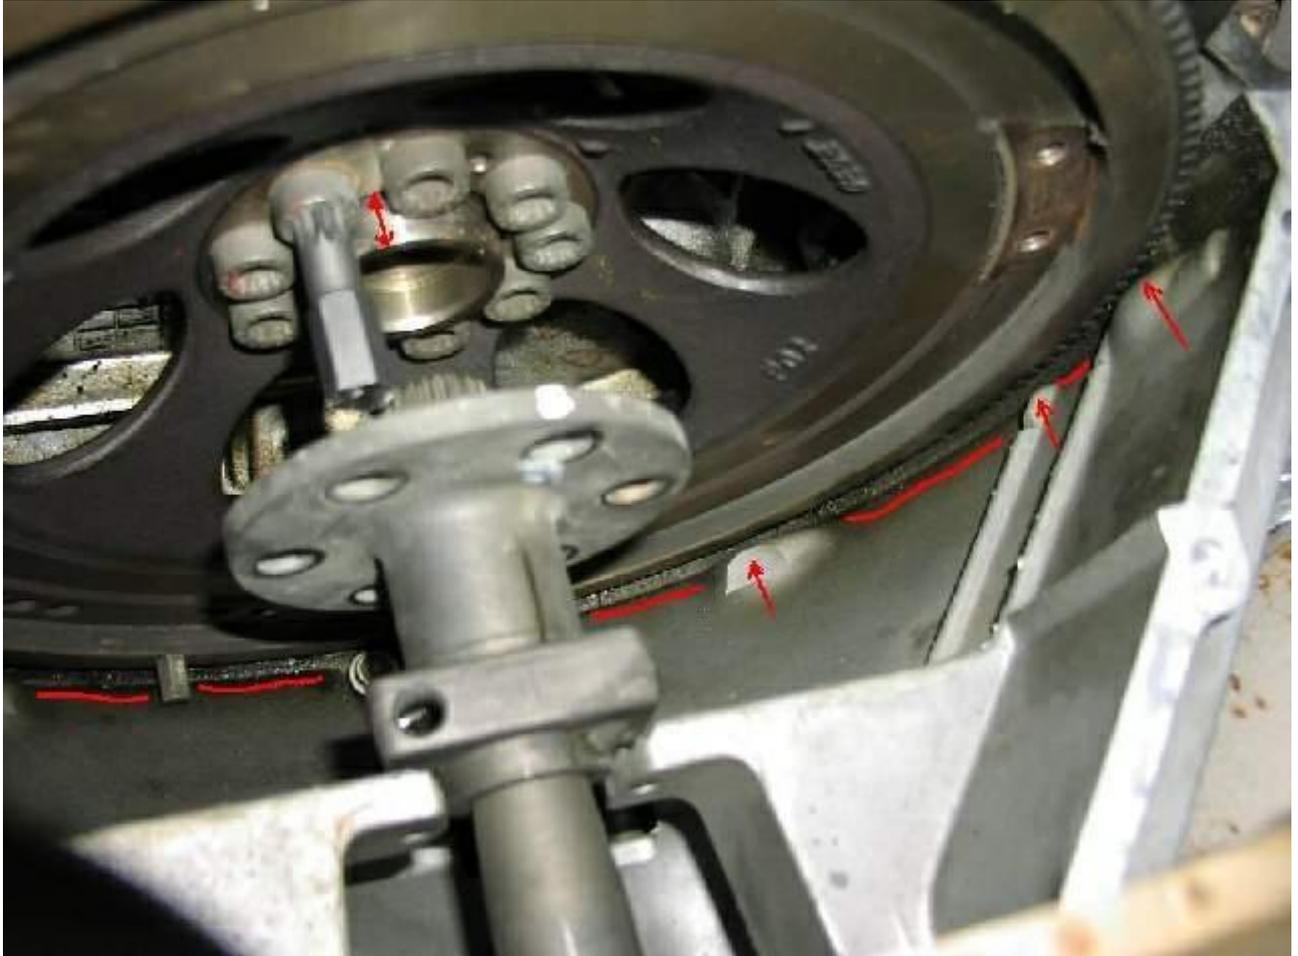
PROBLEM: The bellhousing obstructs removal of the flywheel with the starter ring gear. Unfortunately this is one piece and the ring gear cannot be removed. Note the obstruction points on the bellhousing marked in red. Note boss on the crankshaft marked with the red arrow showing the distance the flywheel must move back to clear it. So, obviously, the bellhousing must be loosened if not removed, and this alone will not allow enough space

for the flywheel to clear the crankshaft boss.

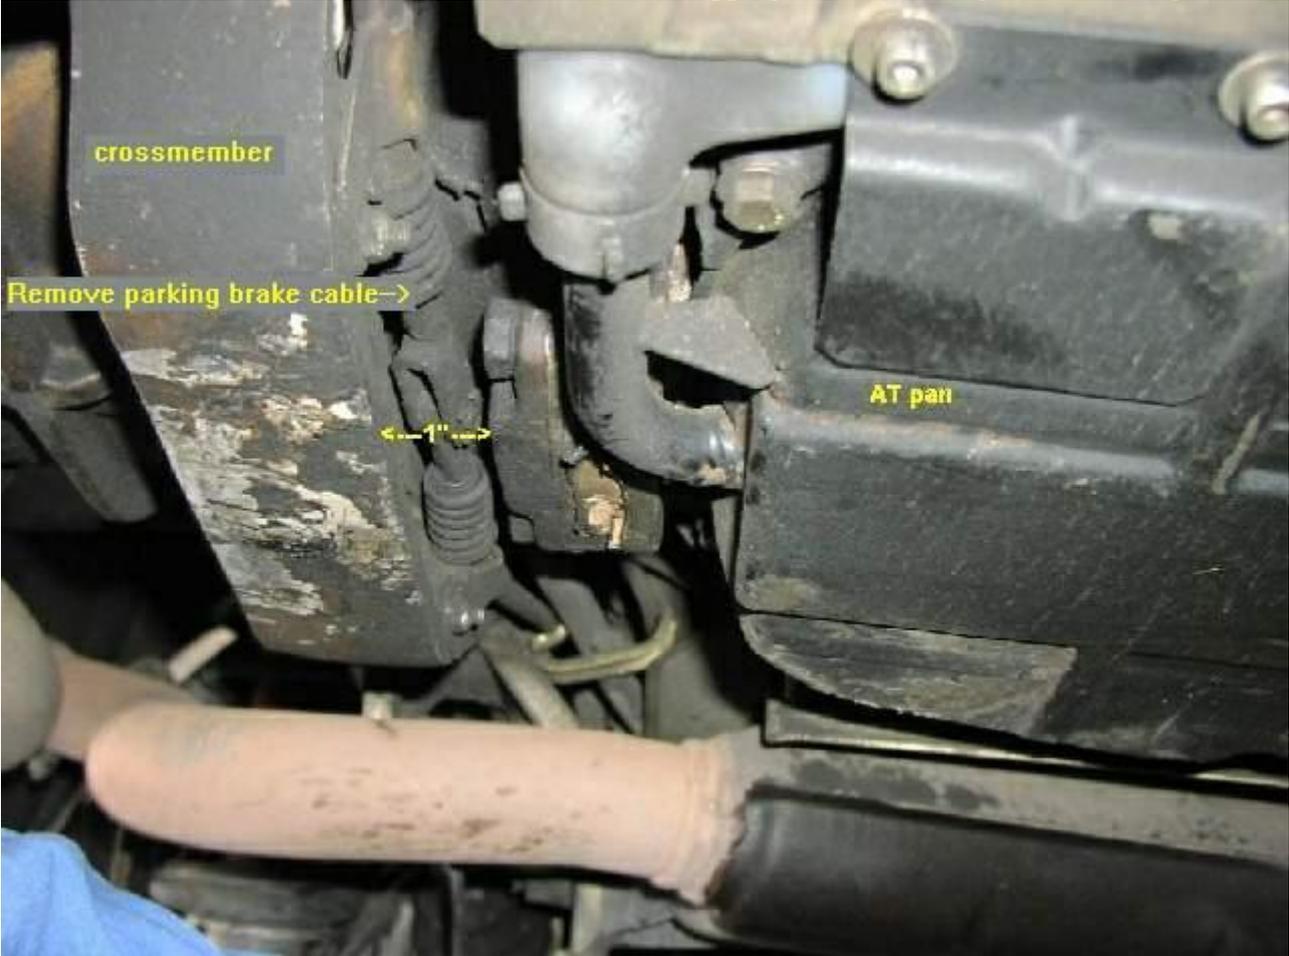
Next problem will be sliding the AT back to allow the bellhousing to move back. There is no way I can see to move it more than an inch short of dropping the whole thing. Is that enough?

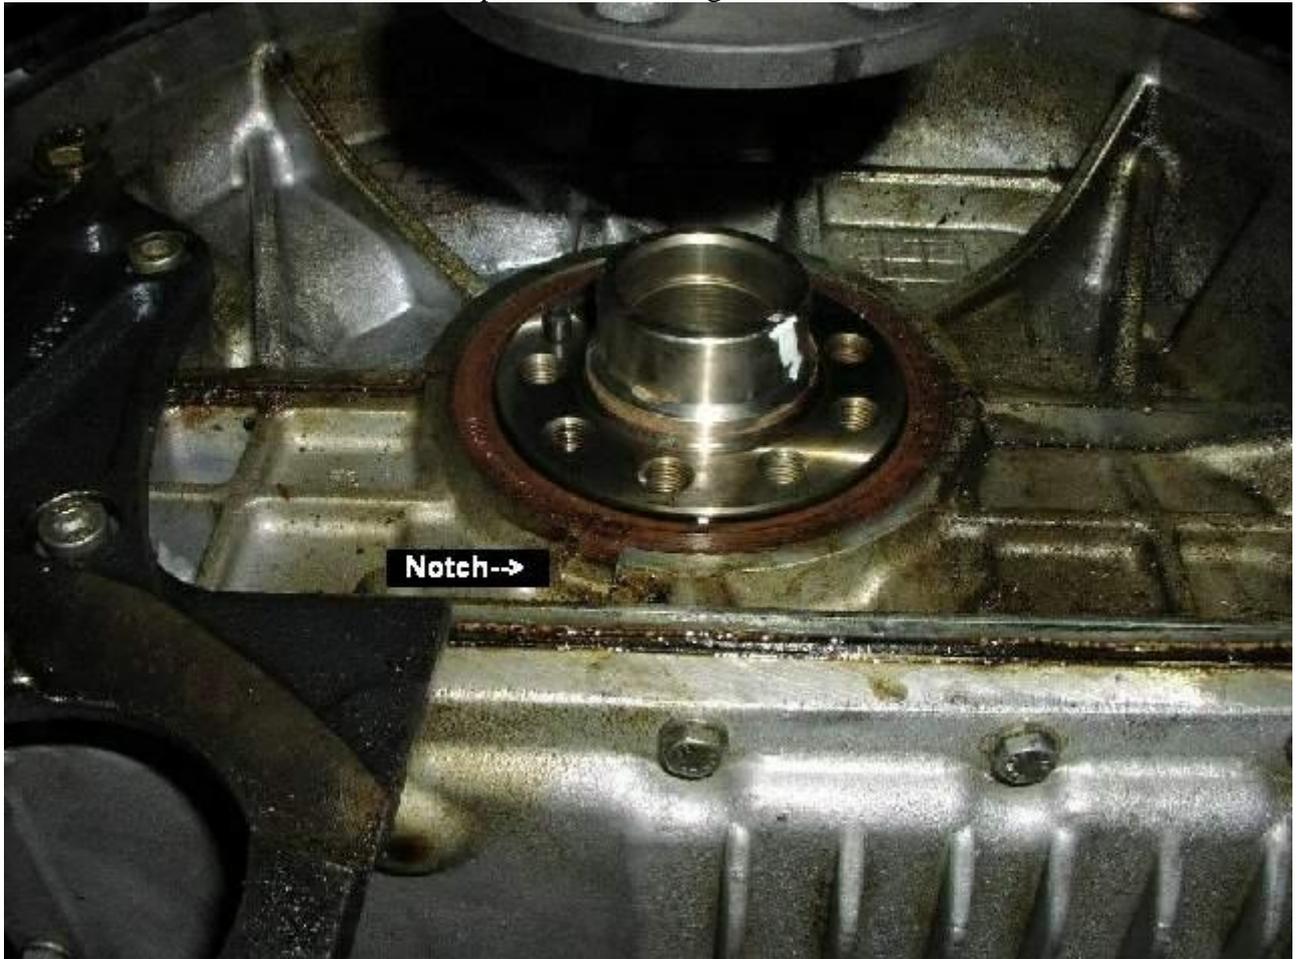
Here is the heart of the matter - the rear main seal. Notice the notch in the block exposing a small section of the seal. This is the point of attack to get the old seal out of the block.

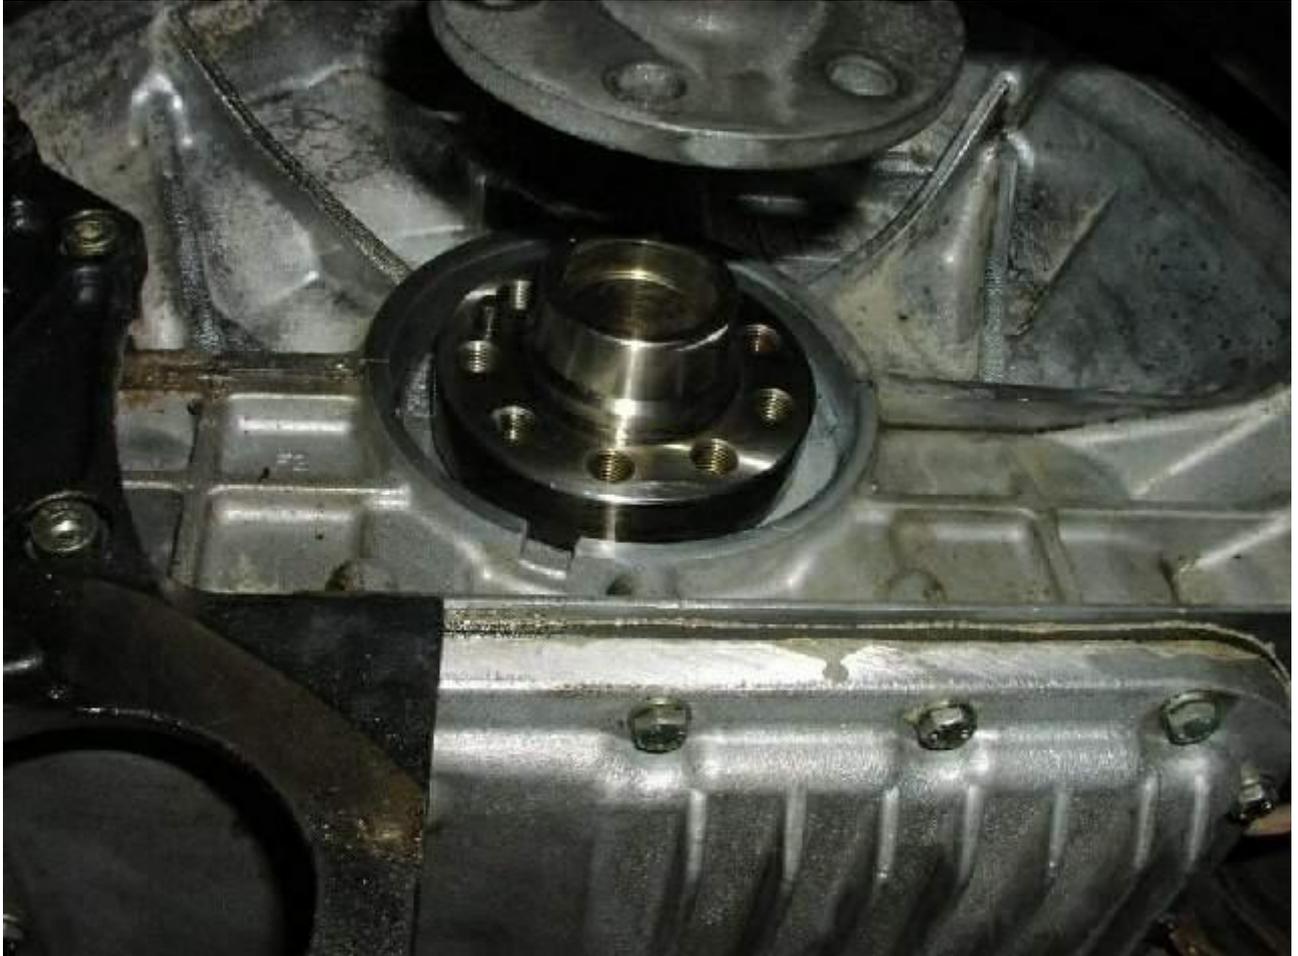
Voila! Seal out. Area cleaned up. The old seal had no obvious flaws.
