1986.5 928S Timing Belt / Water Pump Procedure

by Scott Kelly

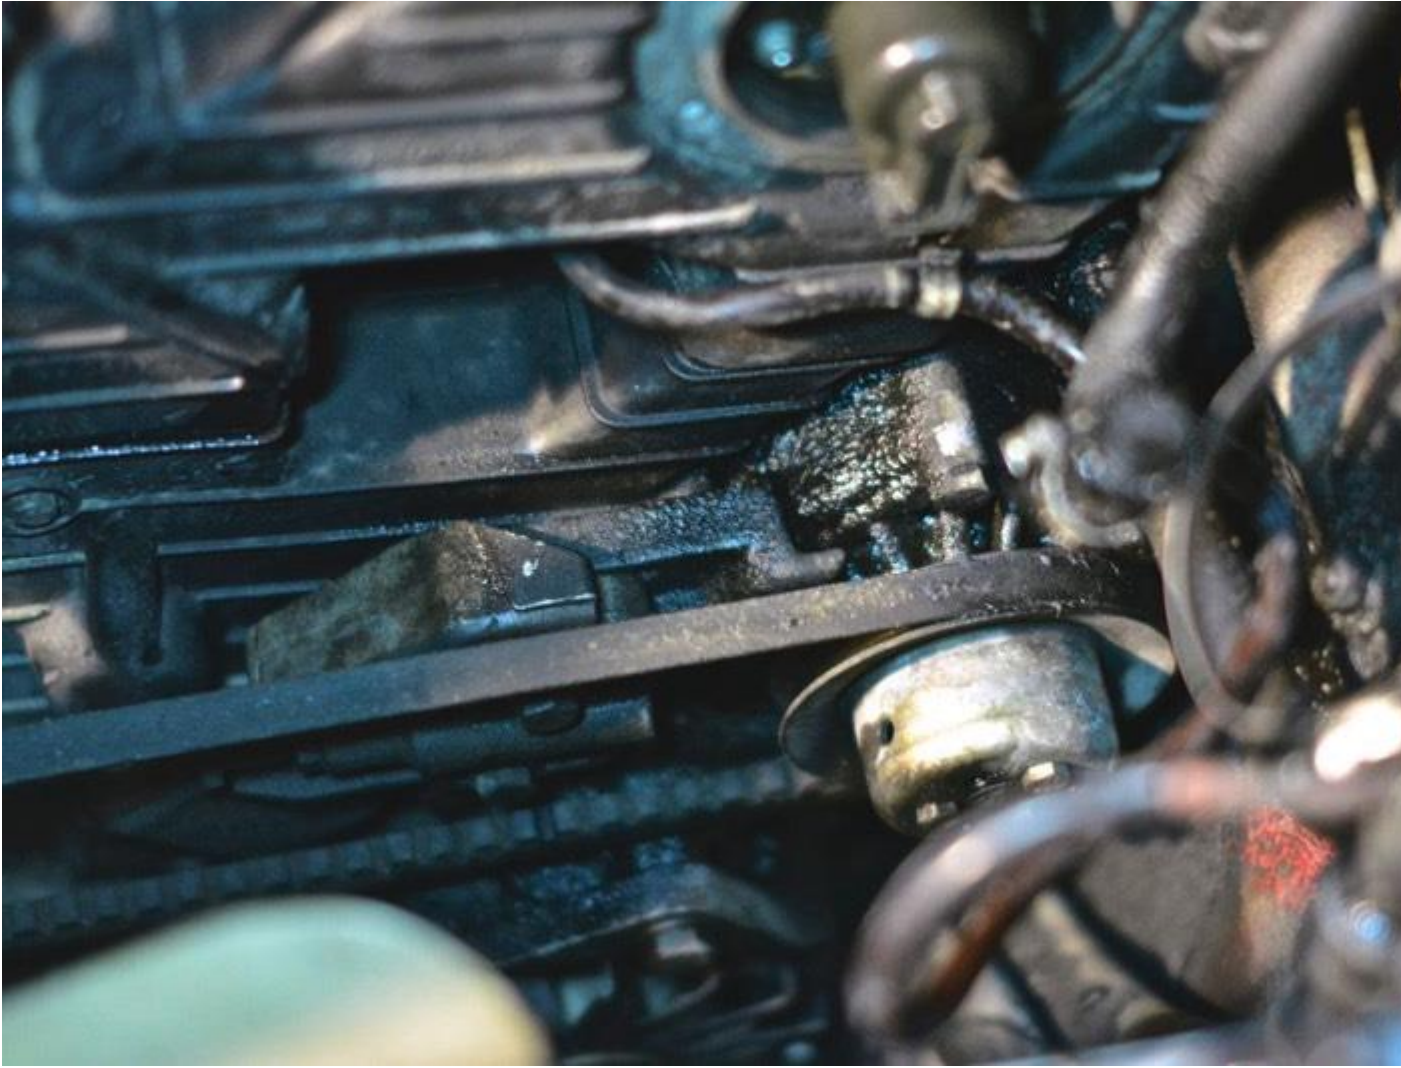
The top end of the engine looked fine, but the front end was an oily mess. With a jug of P21S Total Auto Wash, a spray bottle of water, some Brakleen and brushes, I got to work.

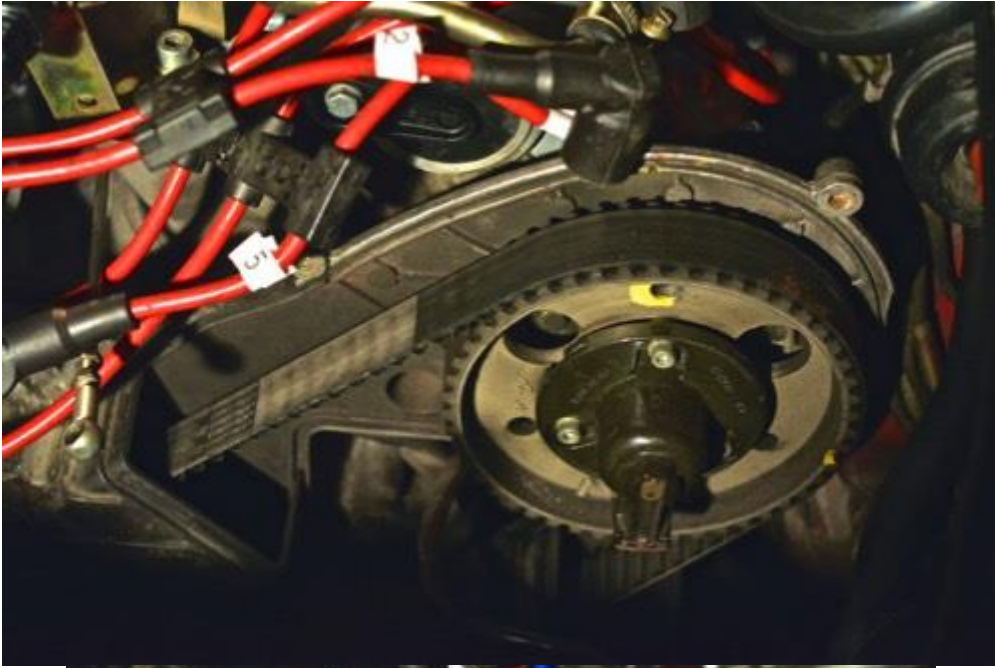
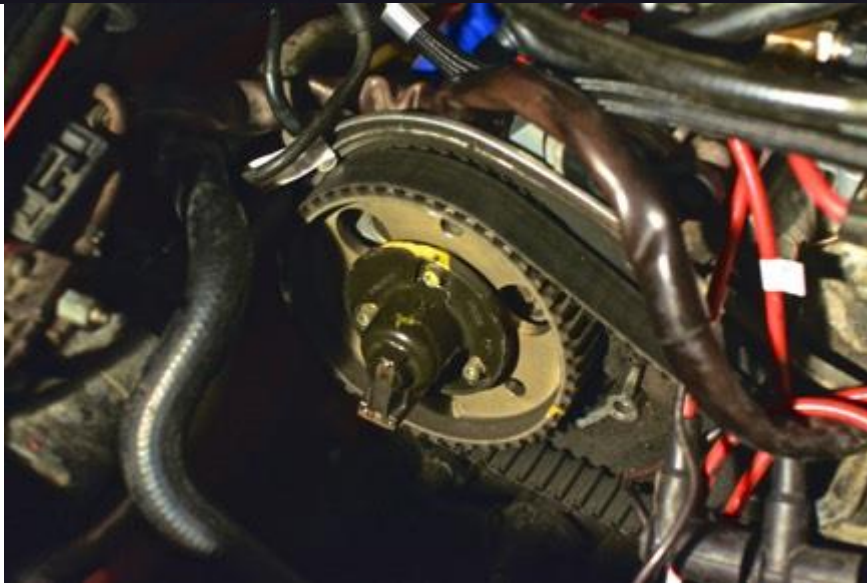
I saw pretty quickly that I would need to replace both cam sprockets. Using a long ratchet and a 27mm deep socket, I cranked the engine 1.75 revolutions to 45 degrees BTDC (*before top dead center*), and installed the flywheel lock tool, which is mandatory for this job.

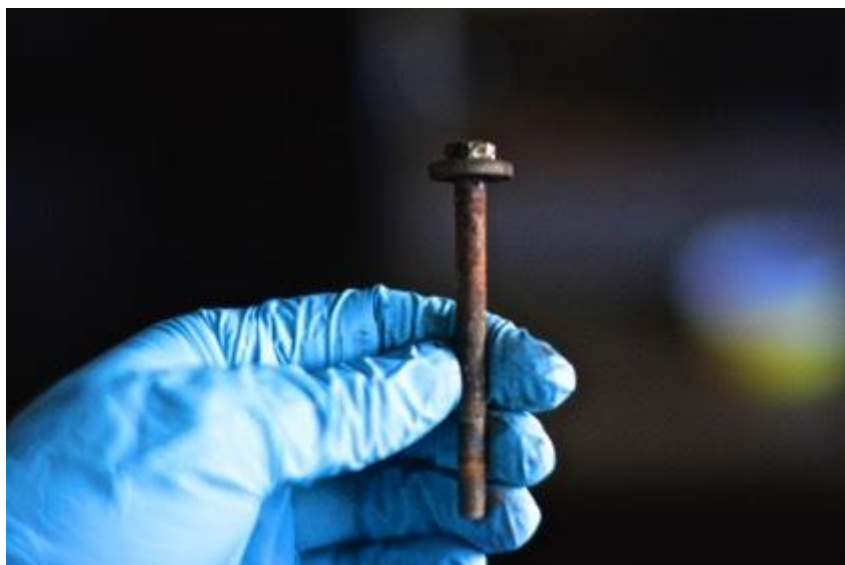
Continuing to get to the timing belt, I removed bolts from the center timing belt cover. The long one attaches to the water pump, and it had rust. I soaked it in Evapo-Rust.

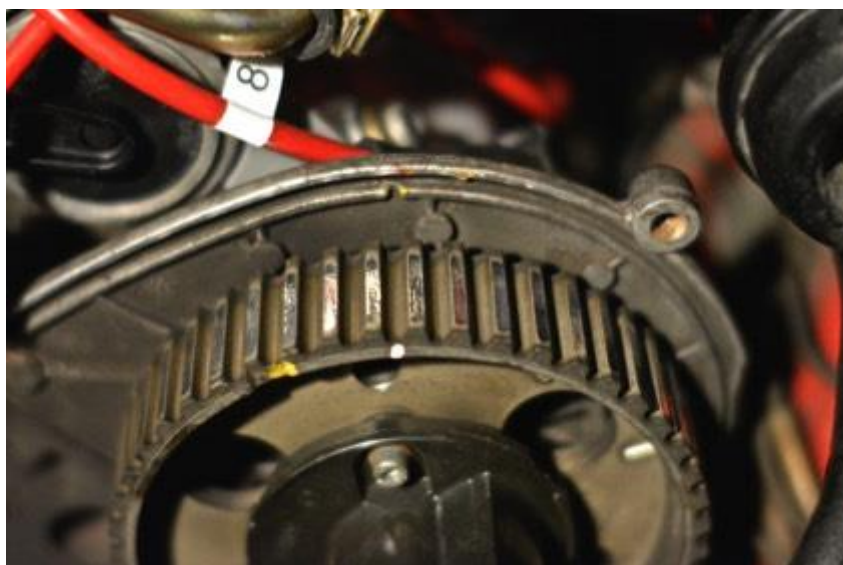
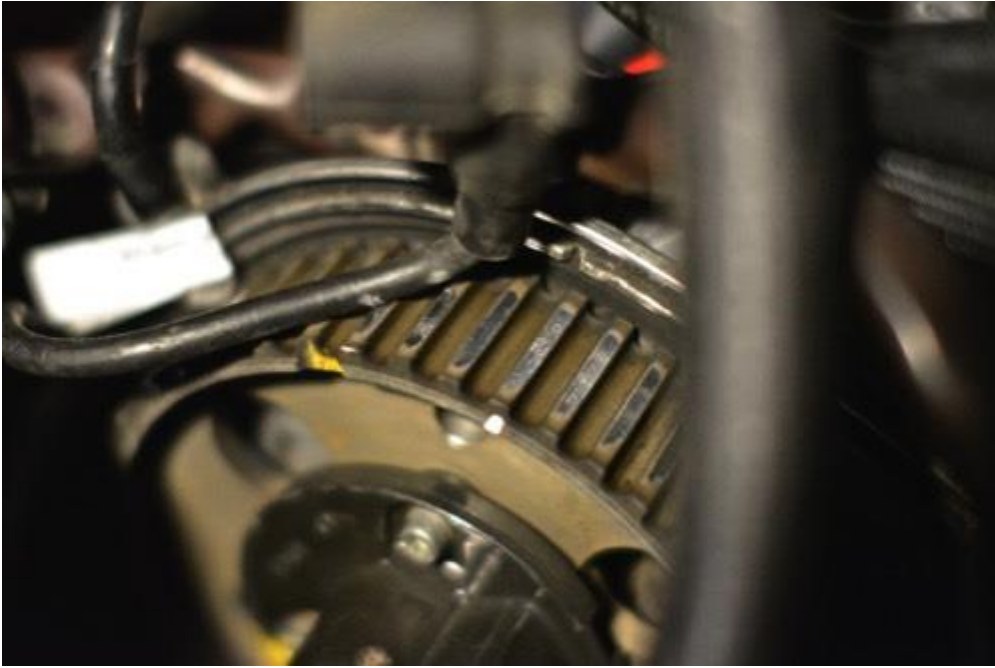
After removing the tensioner arm shaft bolt, I was free to gently remove the timing belt counterclockwise from the upper right (the driver's side cam sprocket.) I was greeted by two very shiny and uneven cam sprockets. I needed replacements.

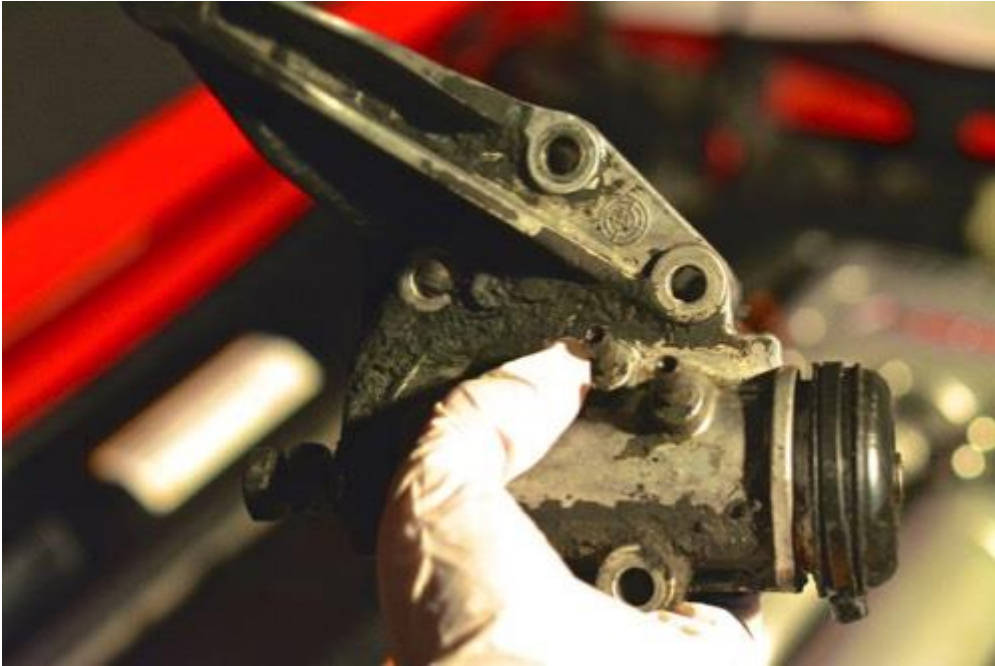
Notice the zip-tie that the previous owner used in place of the tensioner clamp!

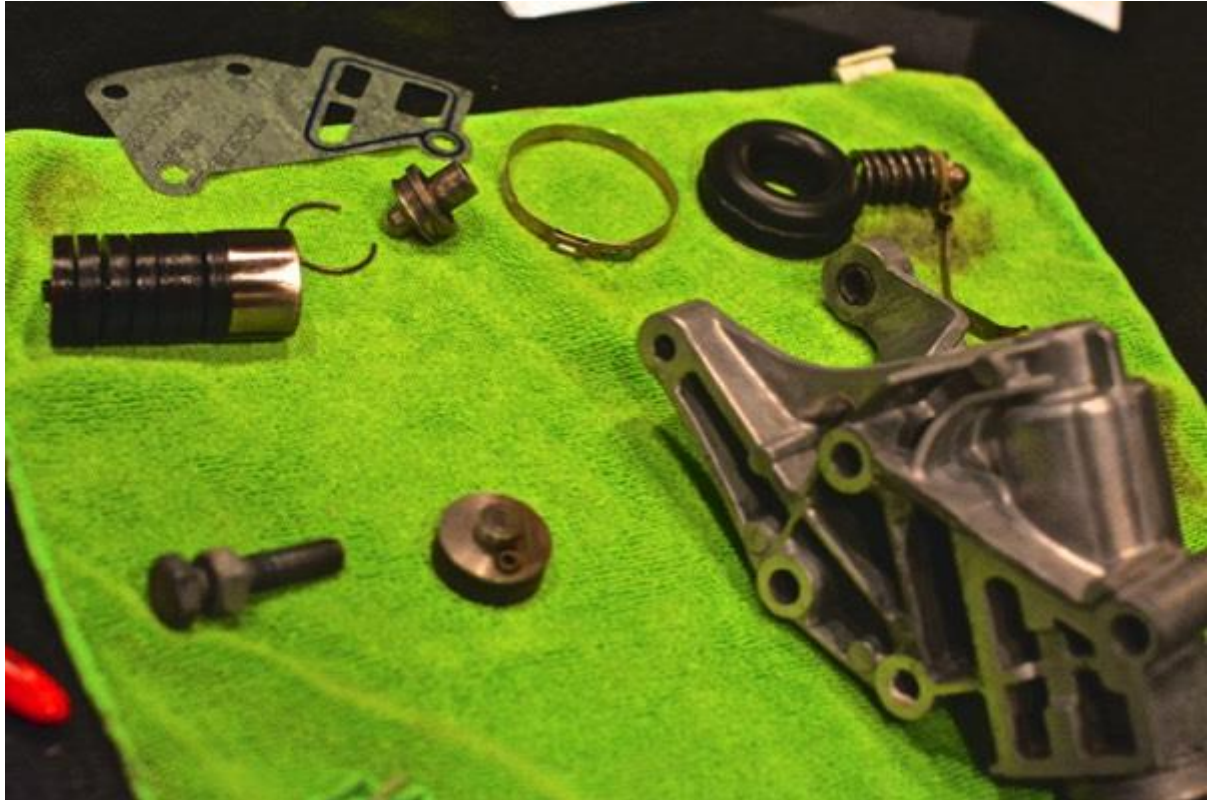
The valve support O-ring came out very easily. As soon as I breathed on it, it cracked.

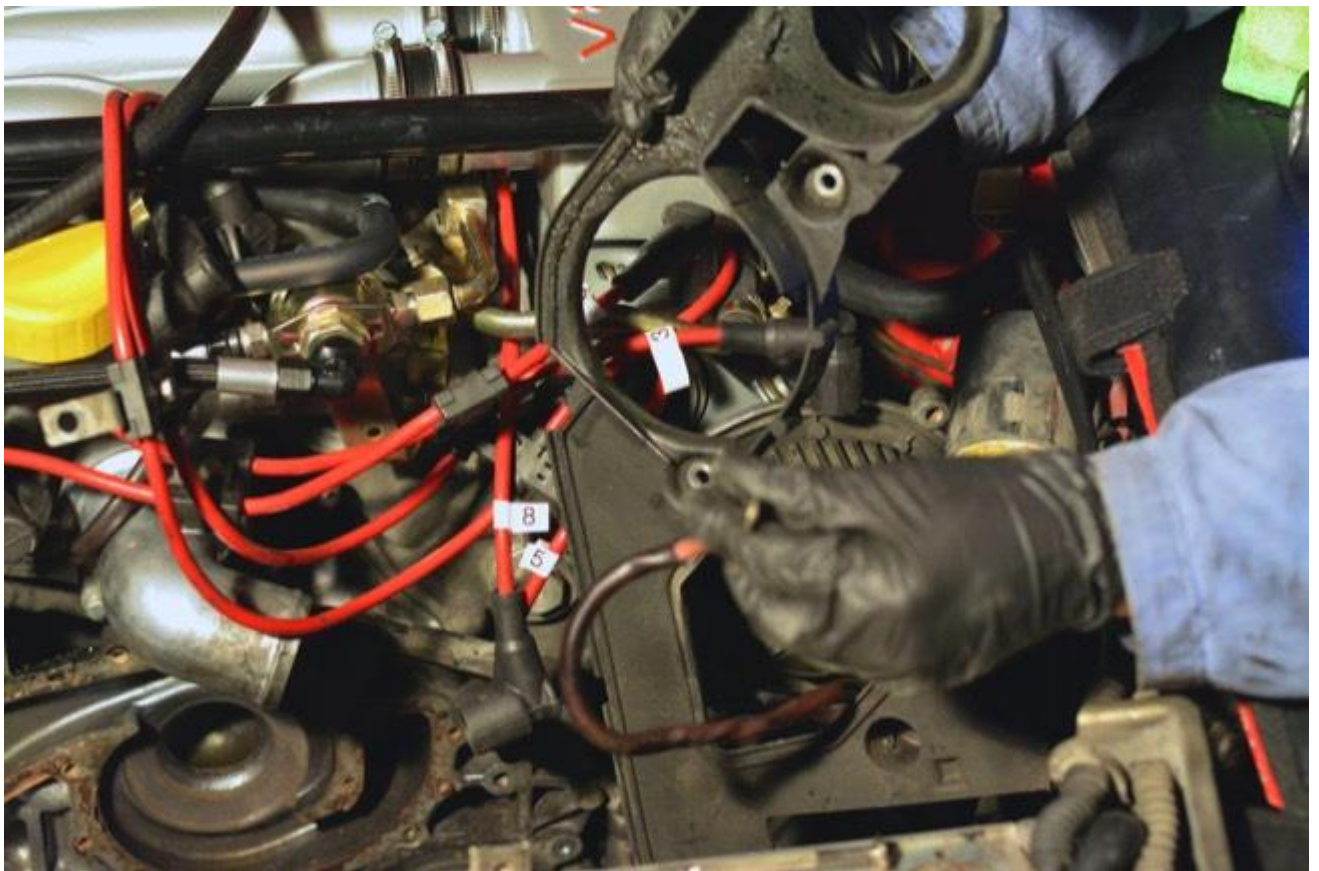
I pulled off the lower idler assembly. In the process, I dropped one of the circlips. I hope

they're still available. The lower idler roller was so greasy and dirty, I have doubts that it was functioning properly. It obviously hasn't been engaged recently.

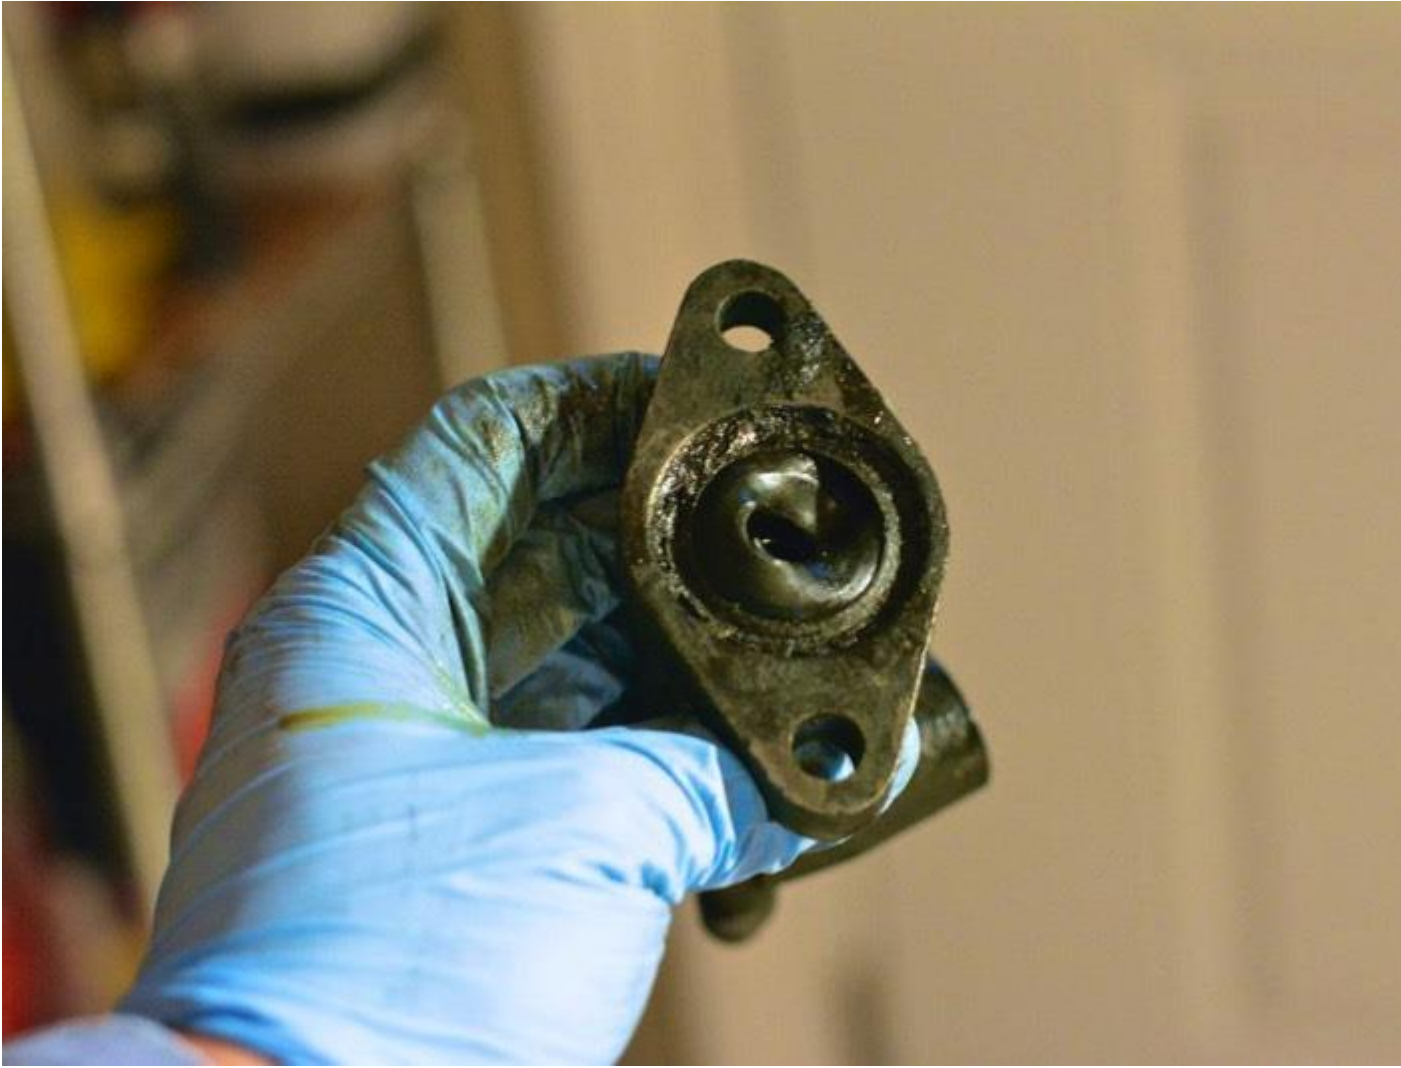
When I installed the flywheel lock tool, I pulled out the Clutch Slave Cylinder push rod (so that I could move the Clutch Slave Cylinder out of the way) and the push rod's rubber cover ripped (as seen below.)

I ordered a Clutch Slave Cylinder repair kit from Roger. It comes with a new circlip, new rubber cover, new retaining ring, new dust cover, and new dust cap for the bleeder screw.

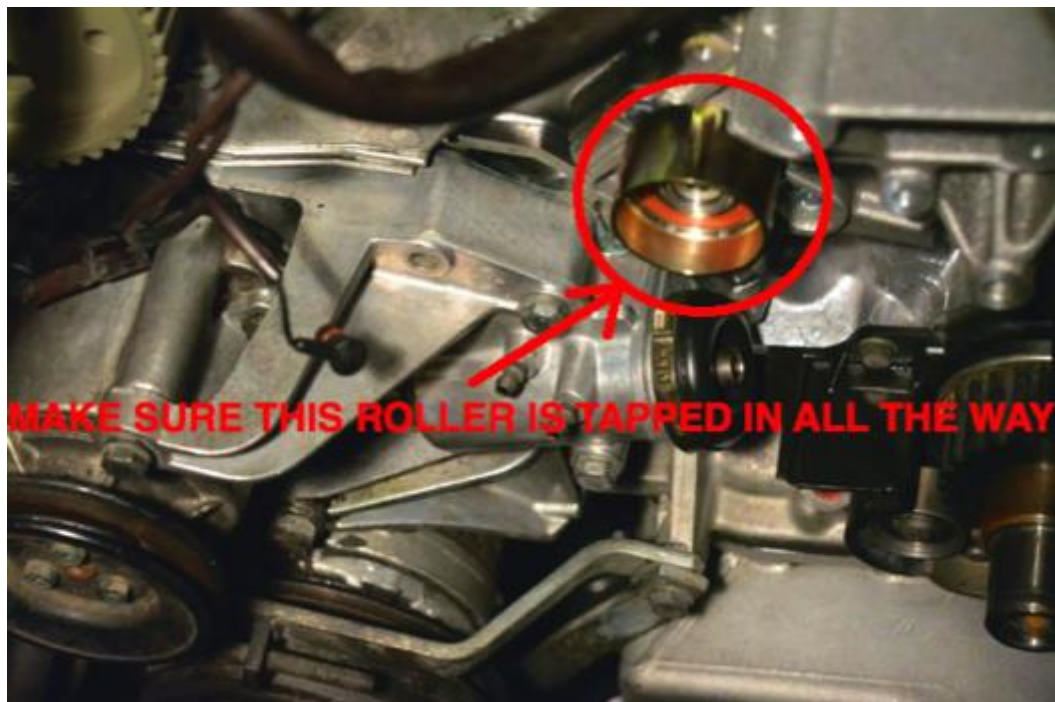
John Kelly's manual states to tap in the upper idler roller [928 105 571 02] with an appropriately-sized socket and a hammer. I did, but not enough.

What did that do? Well, when I installed the tensioner arm, it was touching the upper idler roller, so when I tightened the bolt that goes into the upper idler roller boss, the upper idler

roller stopped moving. Yikes.

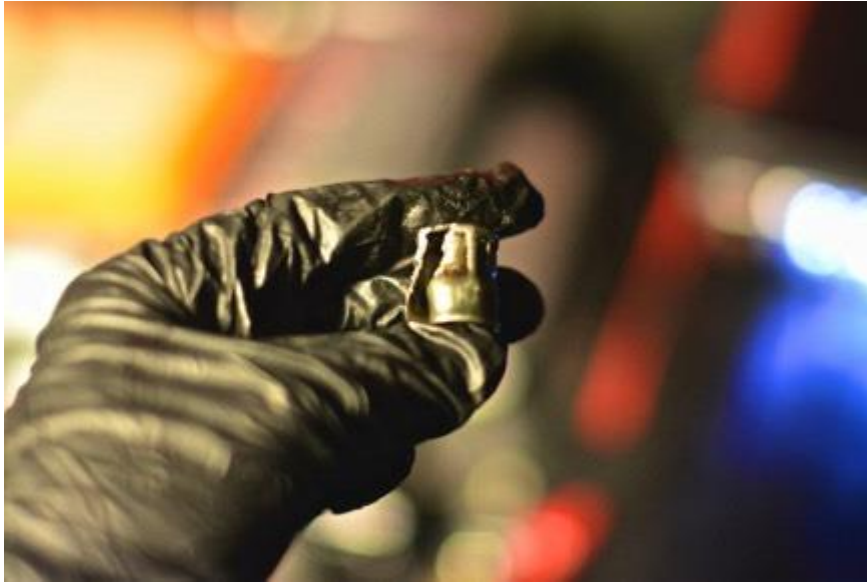
Once you get the crimped end off, you can pull off the short rubber hose that leads to the power steering reservoir. My old hose leaked.

Then I used a hose clamp to attach a new hose to the hard line.
