# 1990 Porsche 928 S4 Auto B2 Brake Band Piston Failure

This report with procedures covers the failure and repair by replacement of the B2 Brake Band Piston Assembly, the maintenance undertaken whilst access was available and the re-assembly procedure with clearance checks for a 1990 928 S4 Automatic Gear box type A28.16/Mercedes Benz 722.3 Series Automatic Transmission.

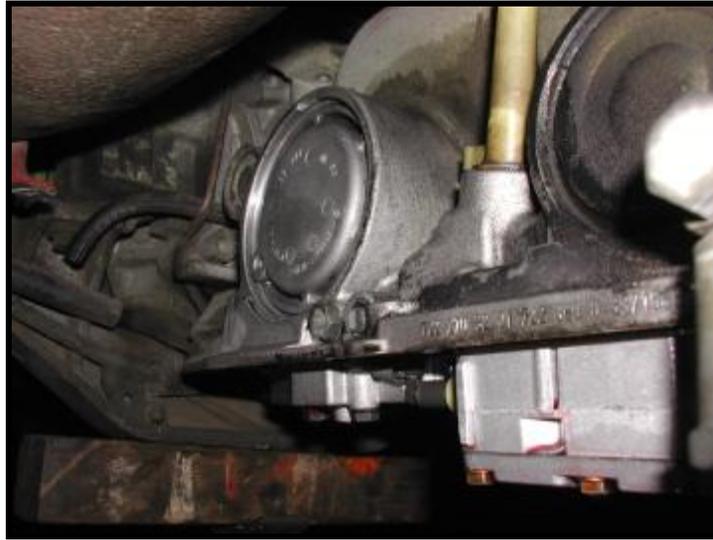
*B2 Piston Assembly Cover Plate*

4. The cover plate is held in position by a circlip and is held against the circlip by the spring loaded B2 Piston.
5. Inwards axial pressure applied to cover plate and circlip removed by using a small screwdriver. To assist in its removal the circlip was moved circumferentially round in its recess until an end was within the gap in the retaining flange. The tang of the screwdriver was placed under the end of the circlip and it was worked out of its retaining groove.
6. Cover plate removed by the use of two small screwdrivers to lever the cover plate out. During removal the plate canted and jammed several times, which required it to be relocated square within the housing. It was not a difficult operation.

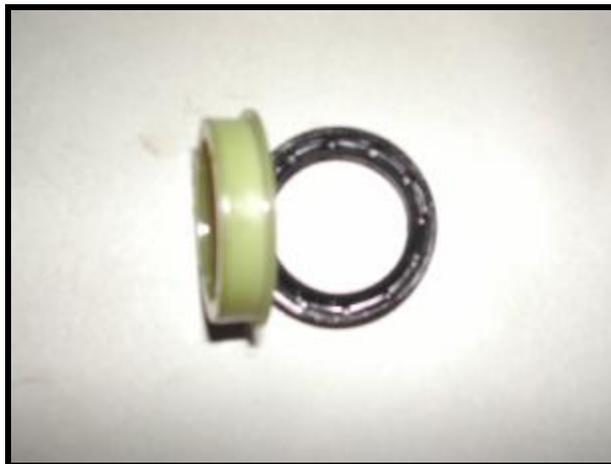
*Bush and lip seal for B2 Brake Band Piston are located at the end of the bore in the aperture into the transmission as shown in the preceding photograph.*

It was decided to renew the B2 Brake Band Piston Assembly, as a total replacement unit, to renew the Cover Plate O-ring seal as well as the lip seal item 7, part number 006 997 734 7, as shown in PET5 illustration number 307-55. To renew the seal it necessitated driving the bush and seal out from the inside the transmission case.

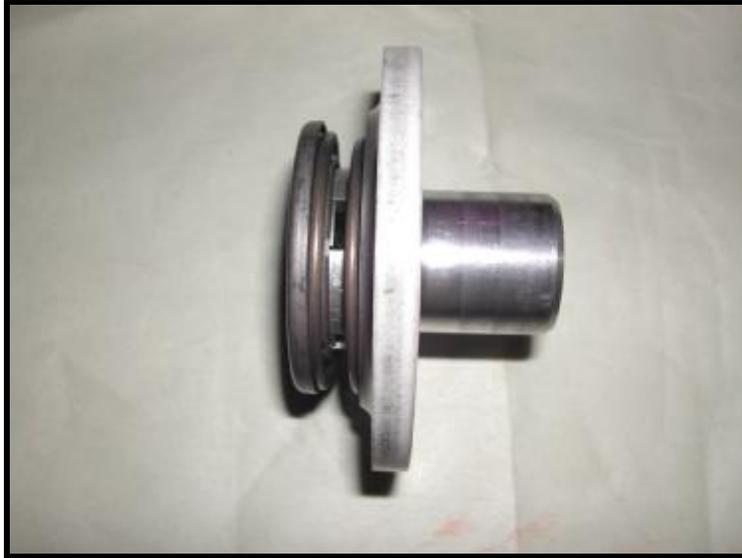
*B2 Brake Band Piston Assembly  
with a view of retaining washer, spring, "T" plastic seal ring and OD of piston cylinder  
where lip seal seals*

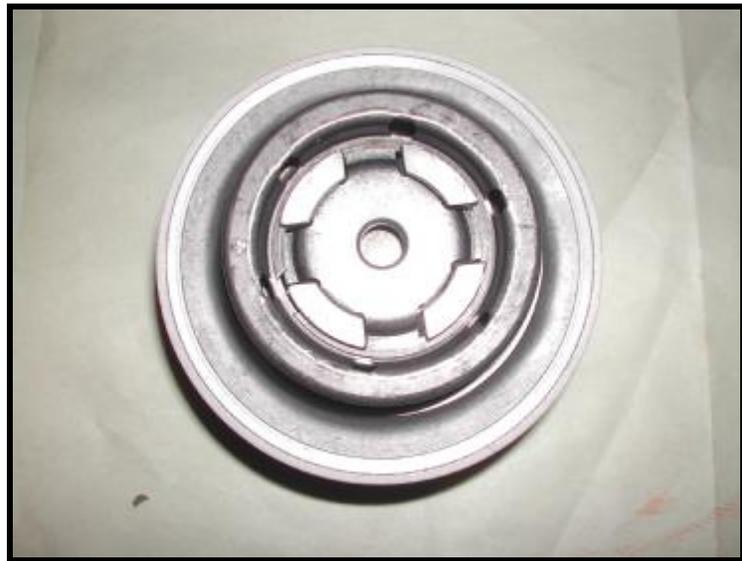
*B2 Brake Band Piston Assembly  
with spring retaining ring, circlip and cruciform piece holding the conical spring and  
non-return valve that can be seen through centre hole*

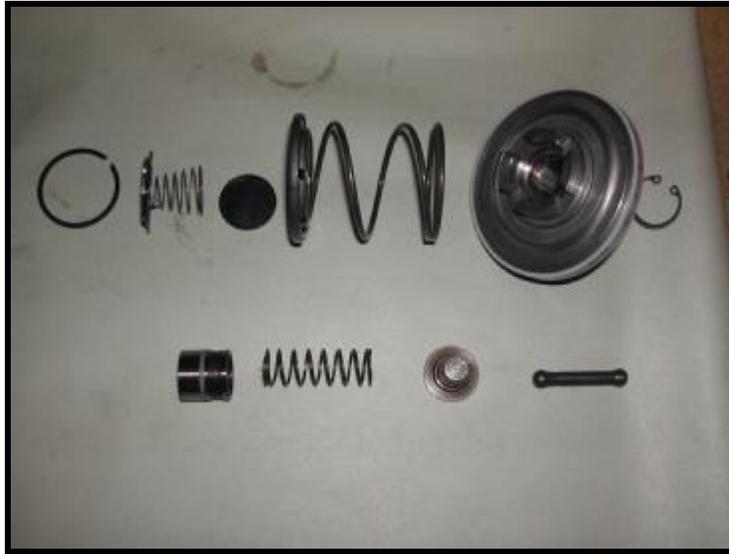
*The B2 Piston Assembly disassembled*

It will be noted from the photograph above that the B2 Brake Band Piston Assembly as removed from the vehicle had the more robust aluminum assembly, it was fitted with the “T” seal ring, however, it still had the steel cylinder liner fitted for the thrust pin actuating piston.

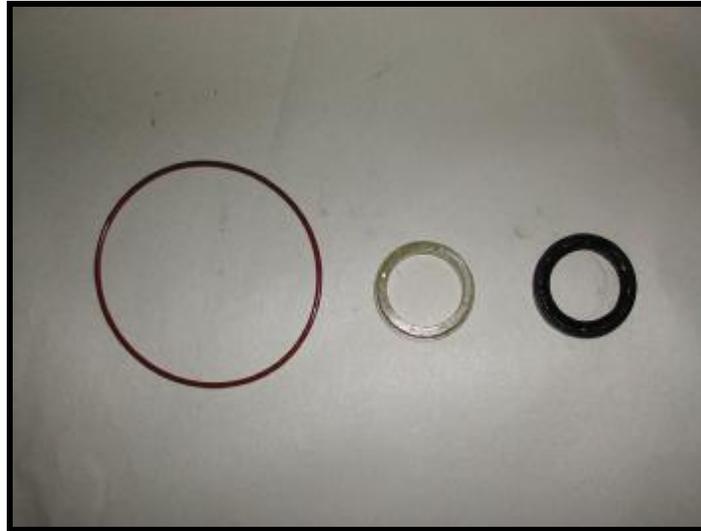
*B2 Brake Band Piston Cover “O” ring, Piston Assembly Bush and lip seal*

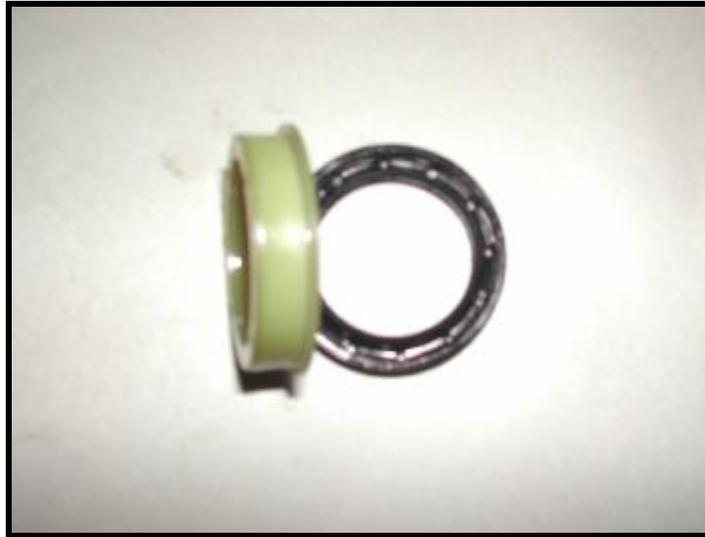
*B2 Brake Band Piston Lip Seal and Bush*

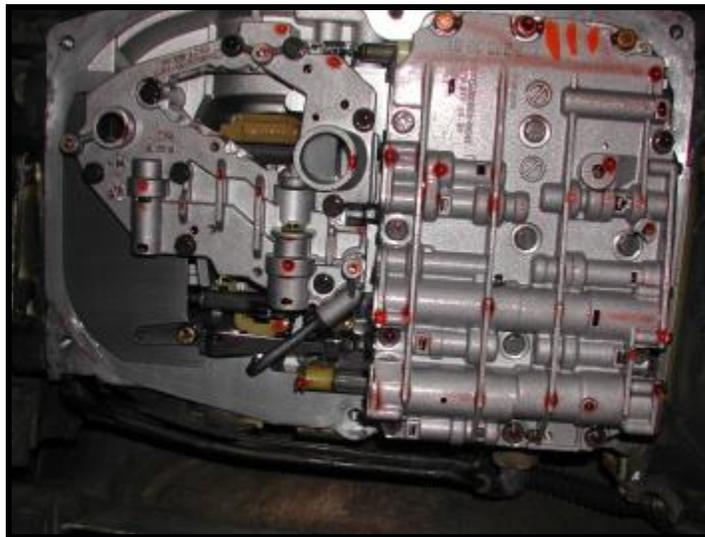
*View of internals of AT with Pan and Filter Removed.*

*On lower LHS space between centre is the oil pipe, detent quadrant leaf spring and Range (Gear) Selection Valve with Slide Head can be seen*

On removal of the oil pan there was some debris from the failed B2 small Piston crown laying in the bottom of the pan, however considering everything the pan was quite clean. The ATF removed was still in very good condition as the AT was serviced in August 2003 at 71,018 kilometres, which consisted of a filter change, gasket change, and a total

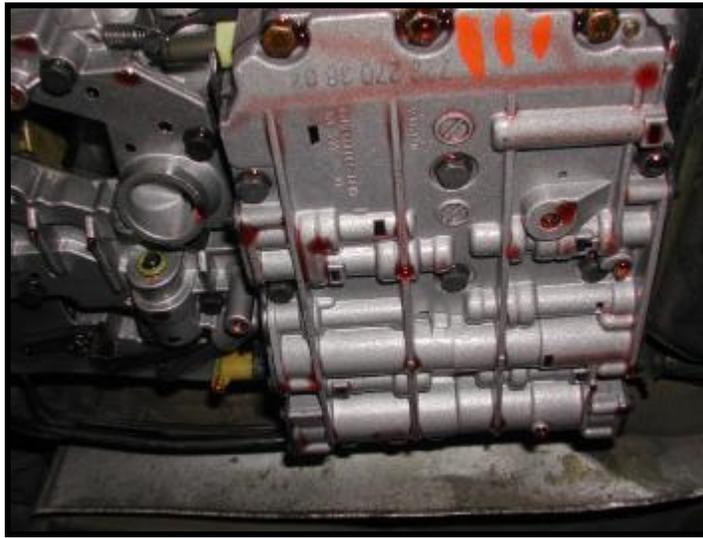
*Automatic Transmission Valve Body*

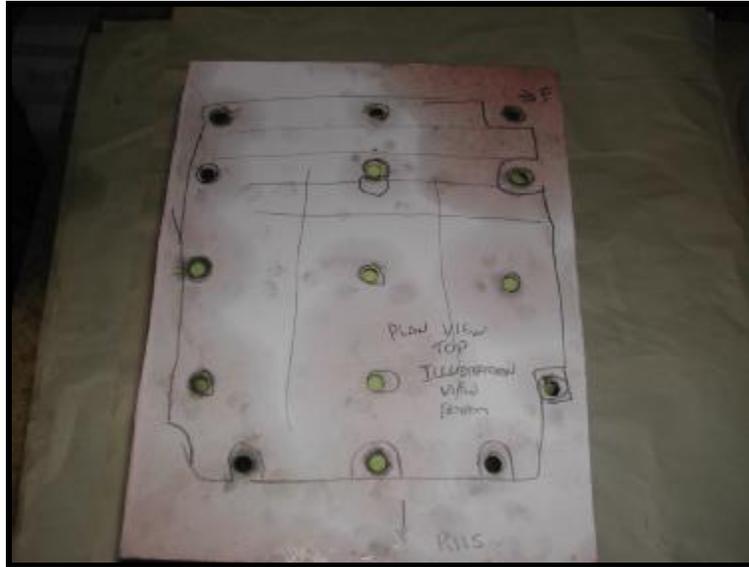
*Valve Body Template to hold set bolts*

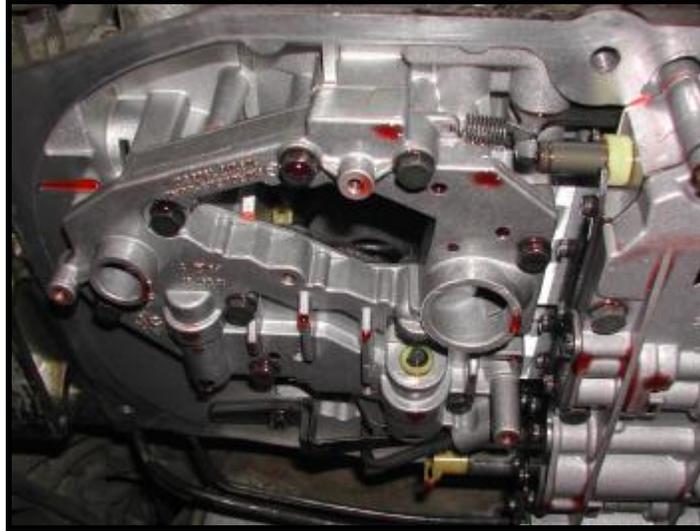
**Lower Cover showing Controlled Pressure Control Valve Piston and Lever in the top RHS foreground with spring loaded actuating lever, Range (Gear) Selector Valve in the lower RHS background with its plastic slide that fits on pin of the detent quadrant and the suction and delivery orifices from the oil filter**

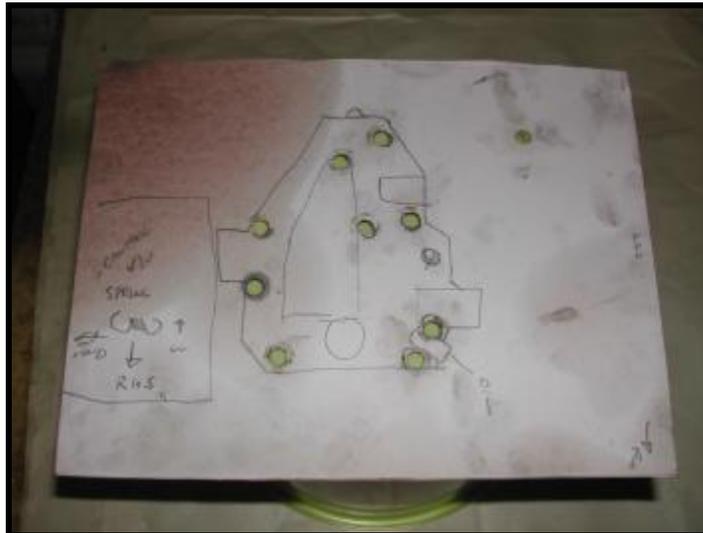
***Lower cover template retaining bolt holder***

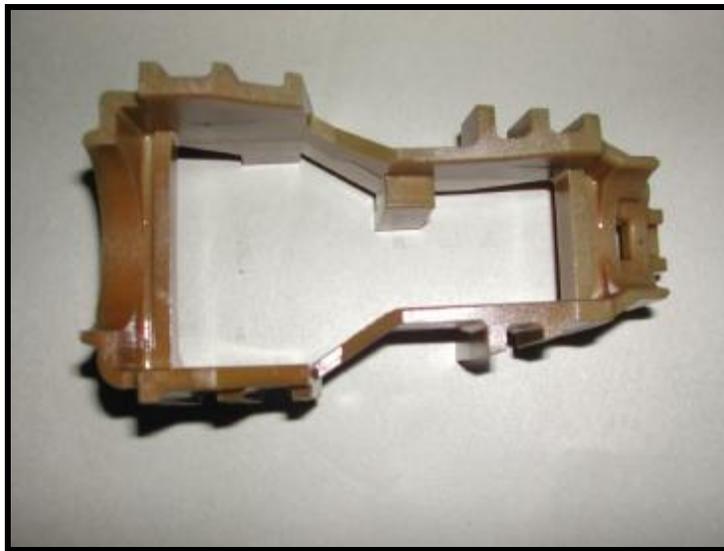
*B2 Brake Band Guide  
Plan view*

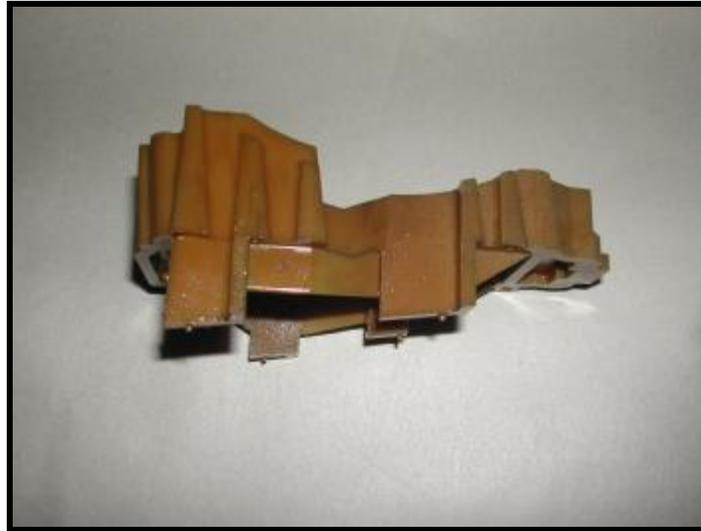
*B2 Brake Band Guide  
Side elevation view*
