# Technical Bulletin

Model  
928 S4

**Subject:** Broken Central Tube Shaft  
Vehicles with Automatic Transmission

Number  
9206

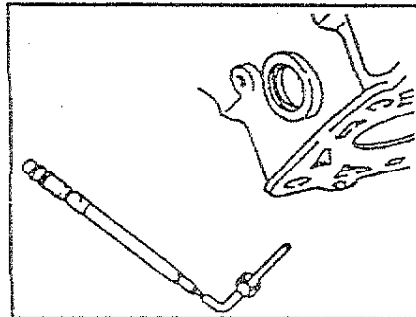
**Concern:** Activation of the ignition monitoring system (injection circuit switched off fault codes 1131 or 1231) can lead to breakage of the central tube drive shaft.

Oscillations in the central tube system that occur when the ignition monitoring system has switched (flywheel effect) can lead to breakage of the central tube drive shaft. This can occur only in vehicles with automatic transmission where the vehicle is operated at an engine speed of approximately 1000 RPM. Possible causes are:

1. If the central tube drive shaft is broken, replace the central tube with the new version part (see parts information). Refer to Technical Bulletin Group 3, Number 9203, dated May 5, 1992 for hints on central tube installation.
