1986.5 928S Timing Belt / Water Pump Procedure

by Scott Kelly

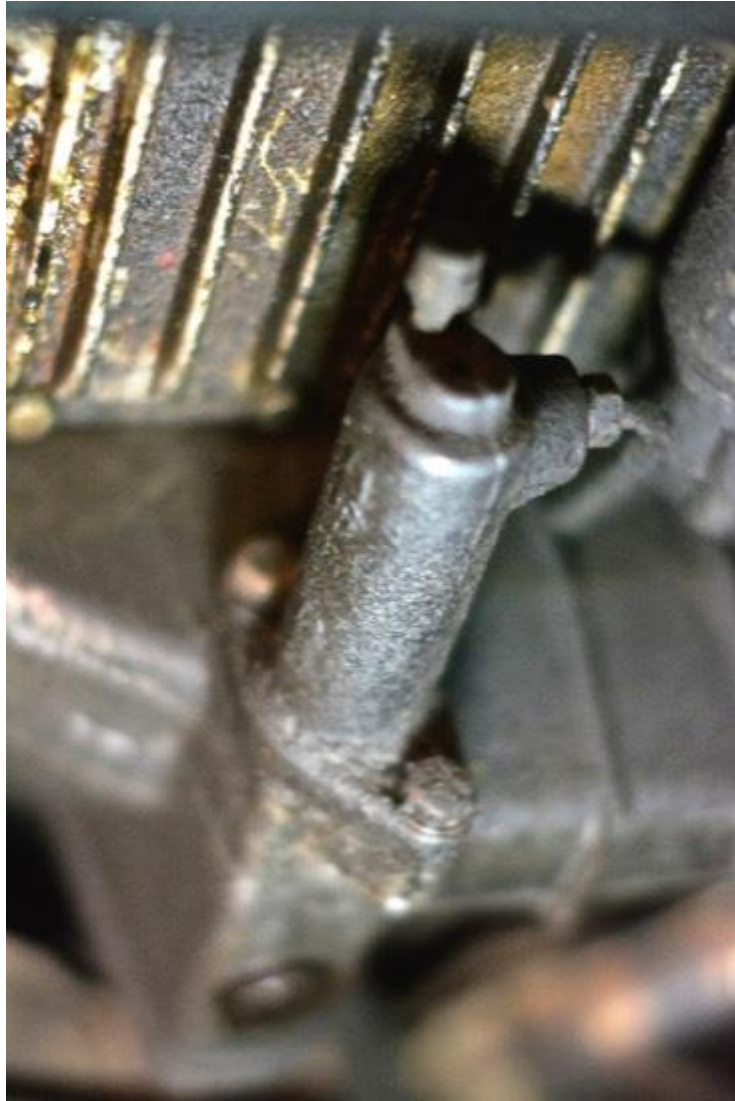
Here is where I made my first big mistake. Since my car has a manual transmission, I needed to remove the two bolts that hold the clutch slave cylinder in place, and move the cylinder out of the way.

Unfortunately, in the process I damaged the clutch slave cylinder. I will cover rebuilding the clutch slave cylinder later.

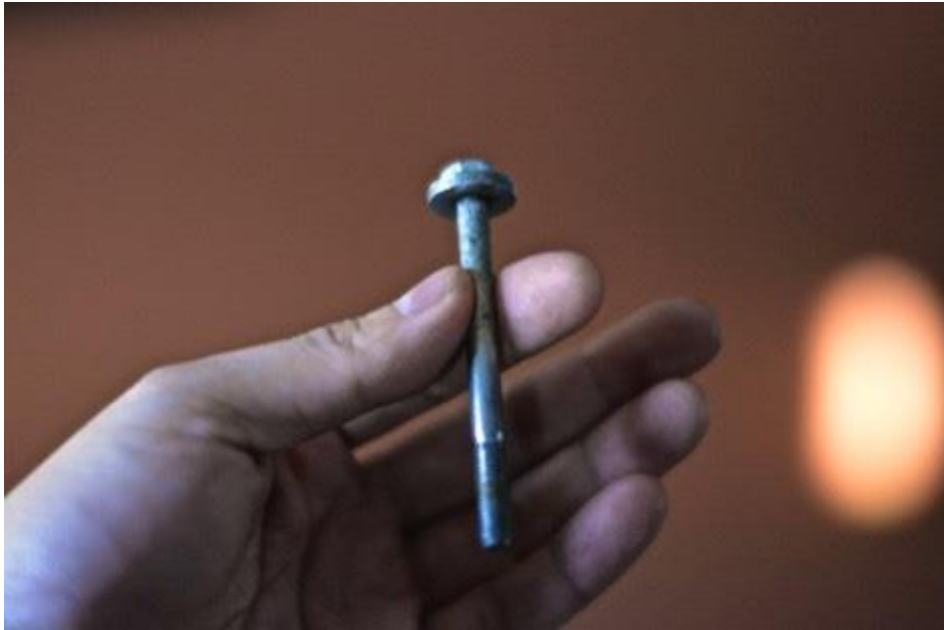
After soaking in Evapo-Rust for a half hour, it came out looking like this. (Amazing, isn't it?)

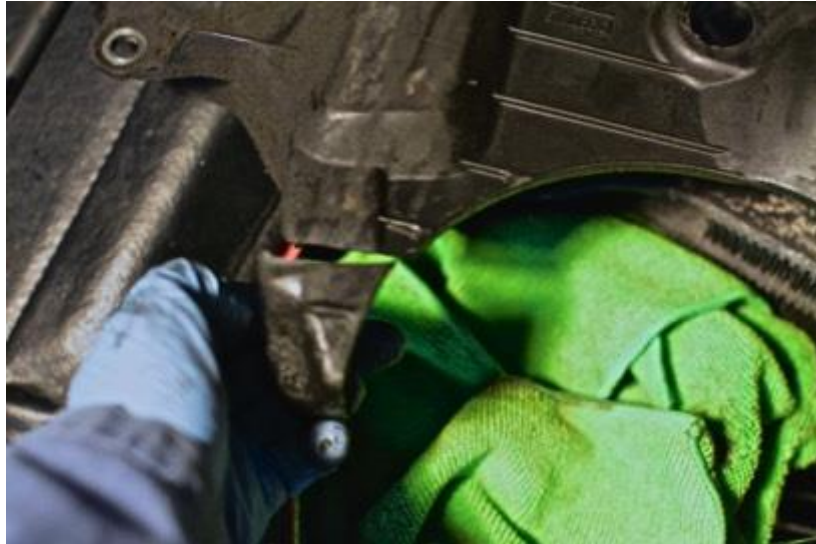
I broke off a piece of the bottom of the center cover.

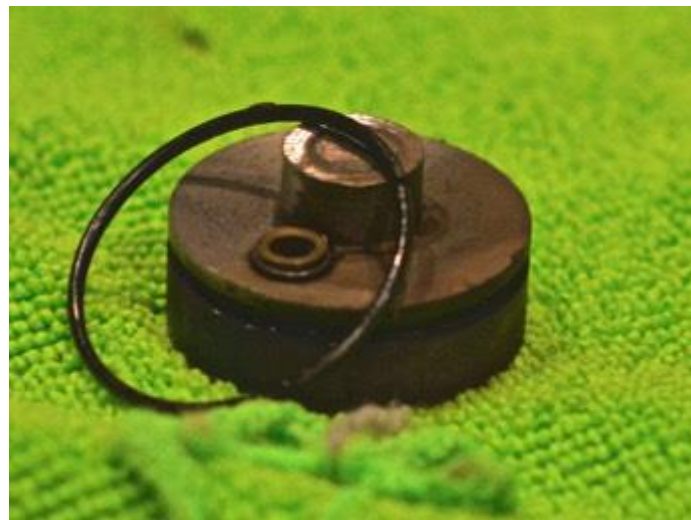
The valve support O-ring came out very easily. As soon as I breathed on it, it cracked.

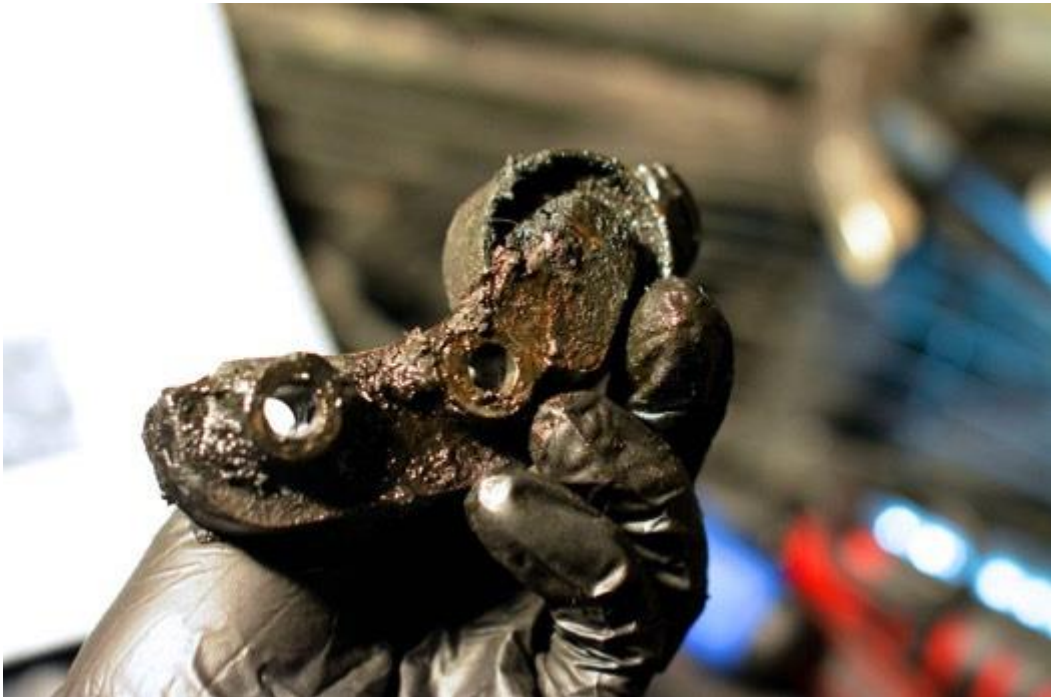
I pulled off the lower idler assembly. In the process, I dropped one of the circlips. I hope

they're still available. The lower idler roller was so greasy and dirty, I have doubts that it was functioning properly. It obviously hasn't been engaged recently.

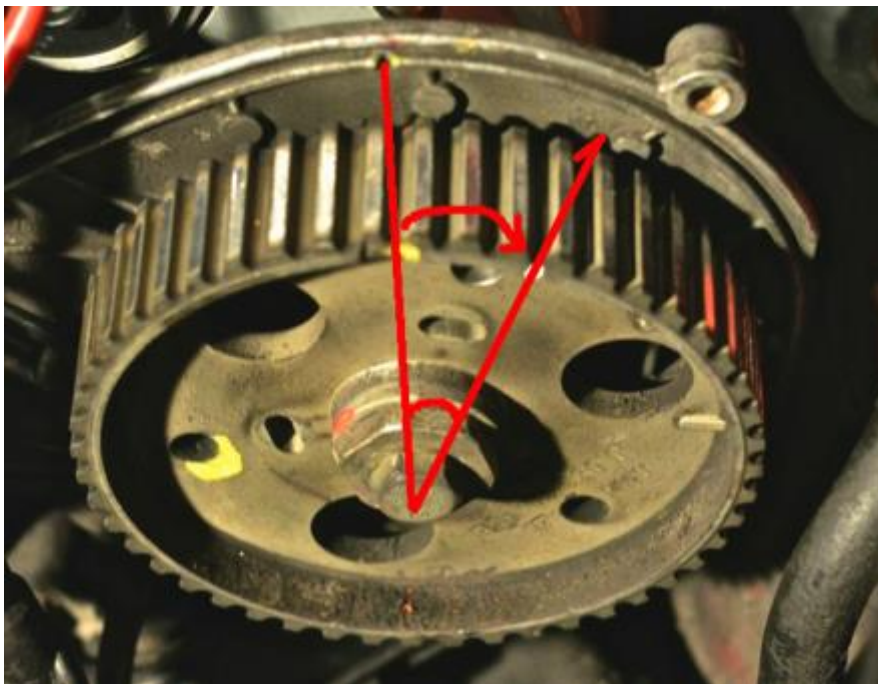
When I wasn't looking, the cam sprocket rotated a few degrees clockwise. (!)

Since my engine was set to 45 degrees BTDC, I was able to turn the cam sprocket

counterclockwise a few degrees in order to restore their proper position.

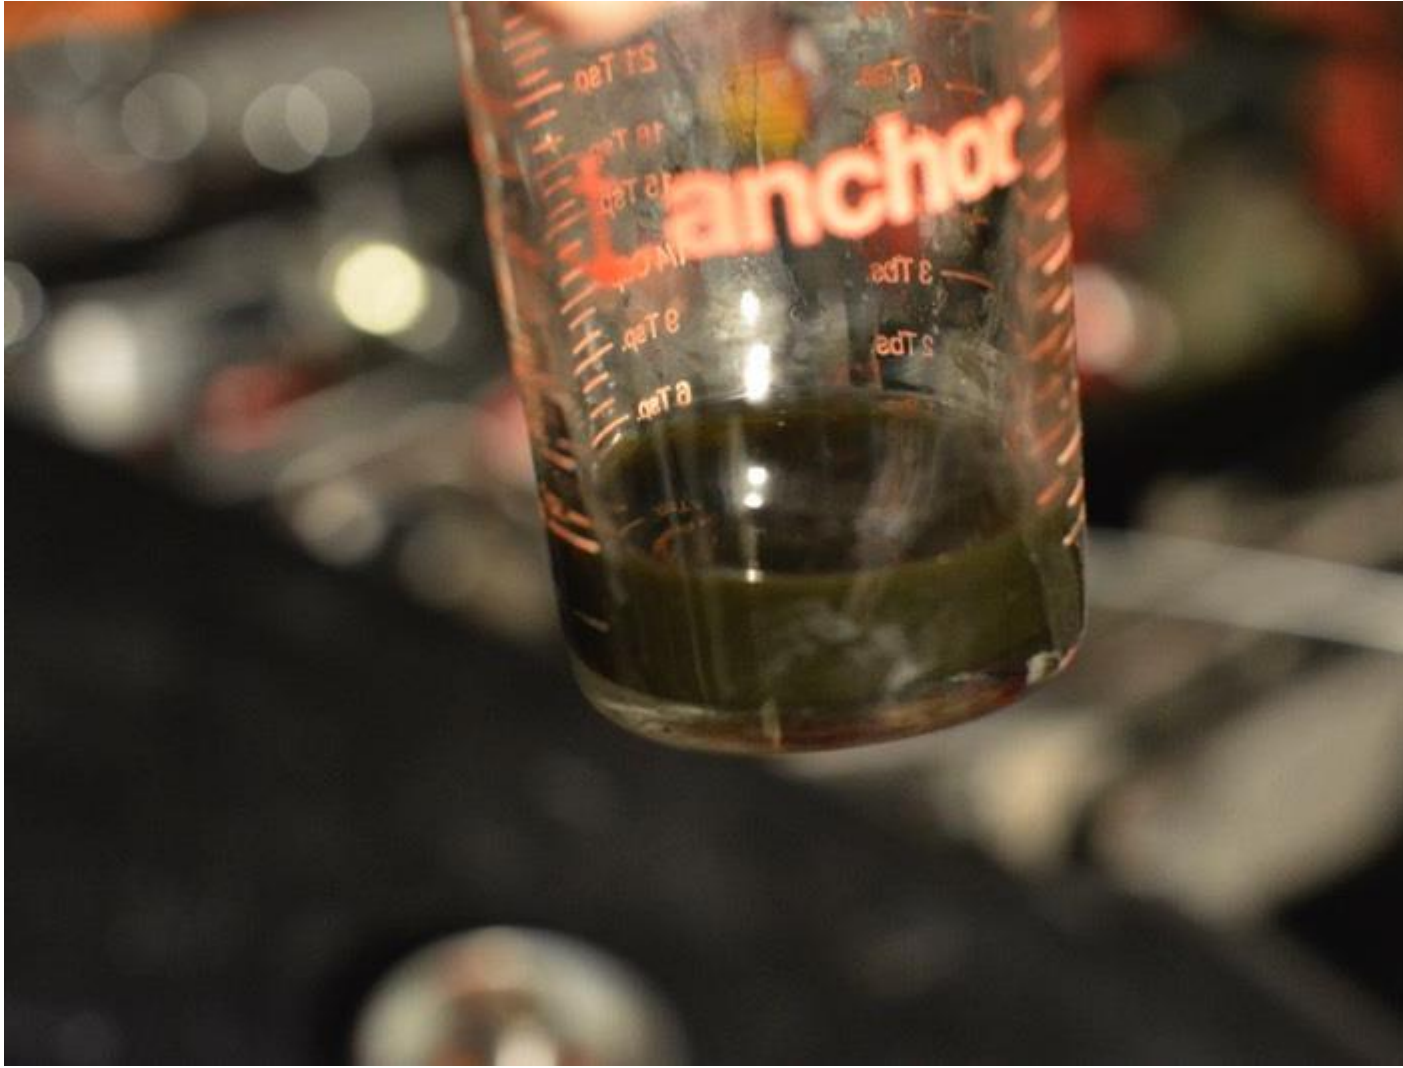
This was the "brake fluid" that dripped out of the Clutch Slave Cylinder. (The clutch and brake systems share the same hydraulic fluid.) Obviously time to bleed the brakes!

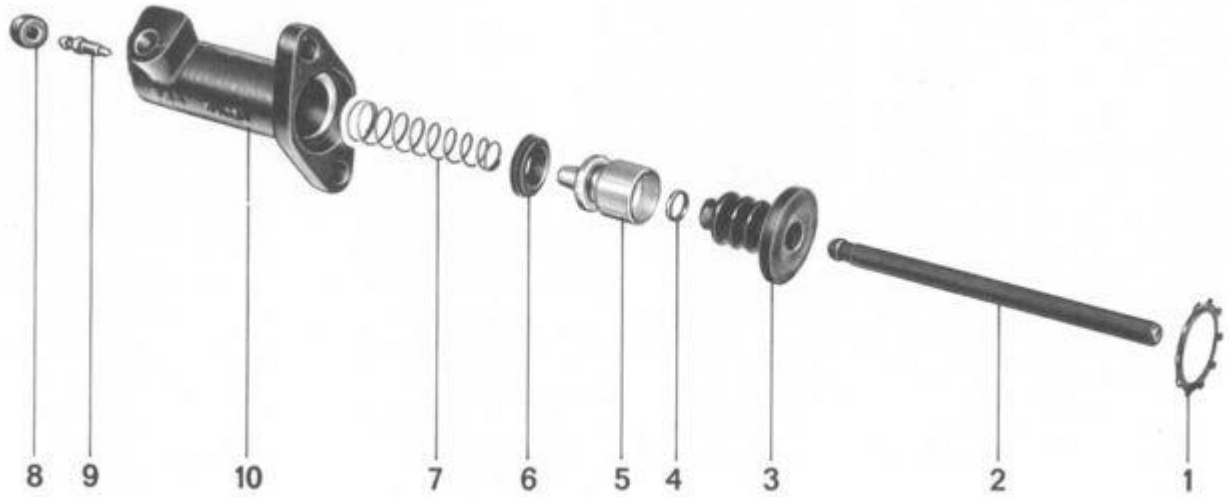
Everything is very clean. The gasket (6) that goes around the piston (5) was difficult to get onto the piston.

I lubed the gasket with grease, which allowed it to slip on.

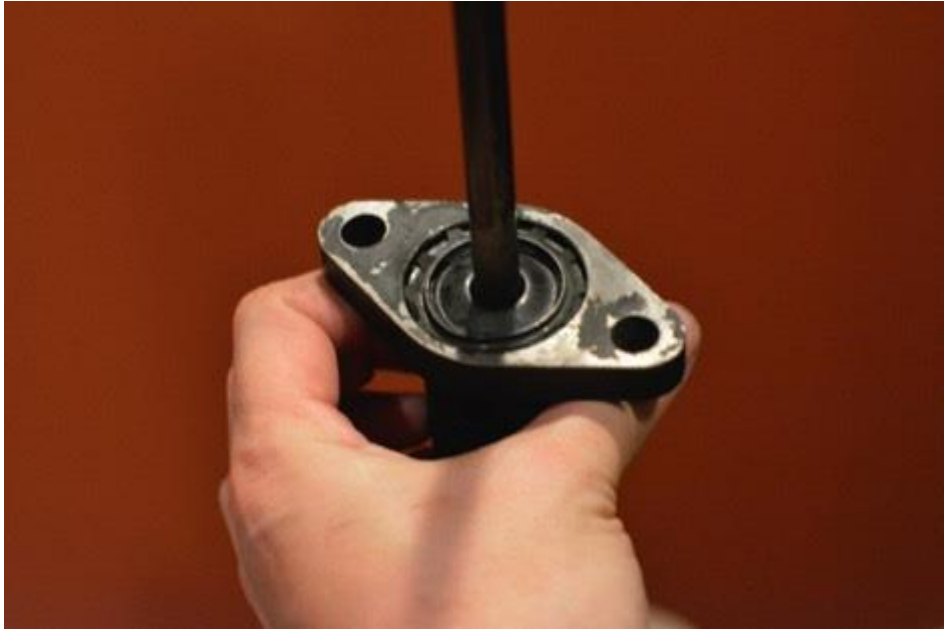
After I re-assembled the clutch slave, there is a circlip that needs to hold the whole assembly together. The circlip was difficult to install for the first time. (It would be easy to do it again.) What I did was:

- Push half of the circlip in, say from 12:00 to 6:00.
- Push 7:00 in with a screwdriver.
- Repeat for 8:00, 9:00, 10:00. What happened for me was that 11:00 and 12:00 would not fit.
- For 11:00 and 12:00 put a screwdriver at the base of the "tine" and lightly tap with a hammer.

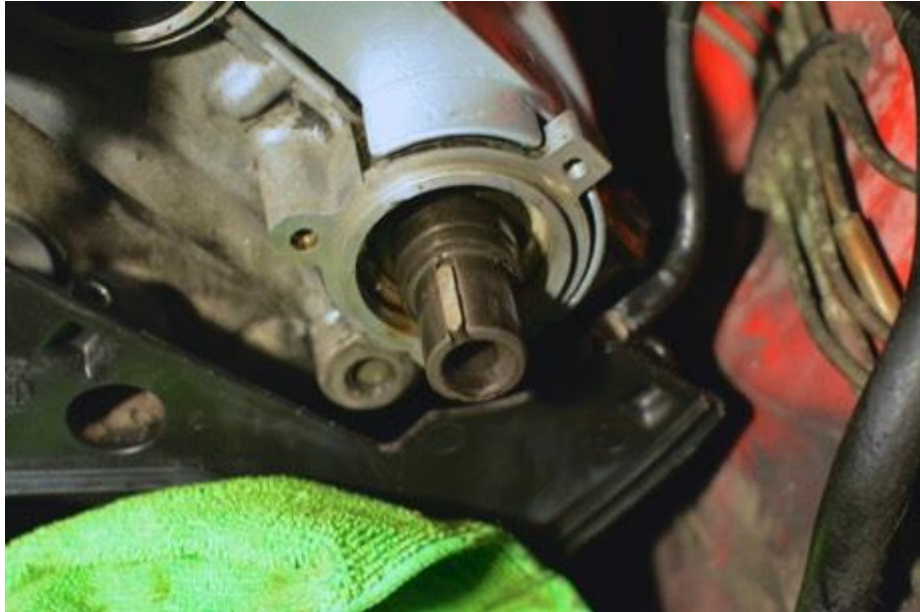
Getting the rubber seal was tricky. I drilled into it (something that always makes me very nervous), and then stuck a thin screwdriver into it and pried it out. Keep in mind that the rubber seal is rubber-coated metal.

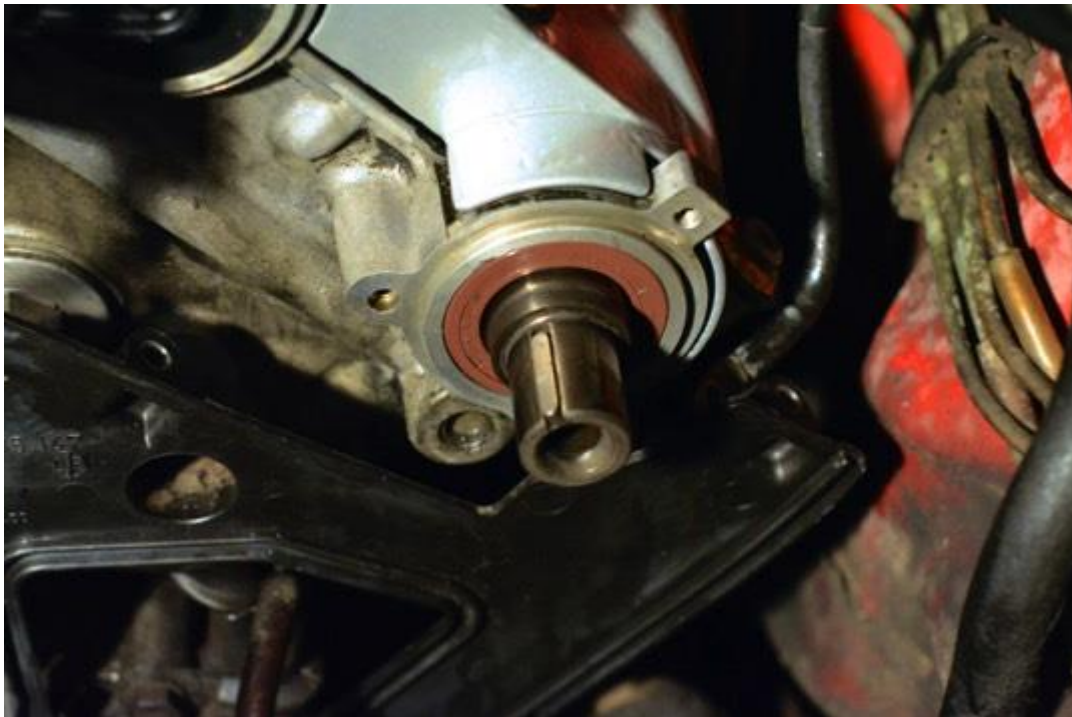
Pushing the new cam shaft seal [999 113 282 40] is easier than pulling out the old one. However, the first couple of times I pushed the seal in, the circular spring (looks like a silver hula-hoop for a Barbie doll) was dislodged from the inner circumference of the seal. Upon my third try, it seemed to be okay- although, since I cannot see through metal, I am only 95% sure that the spring is properly in place.

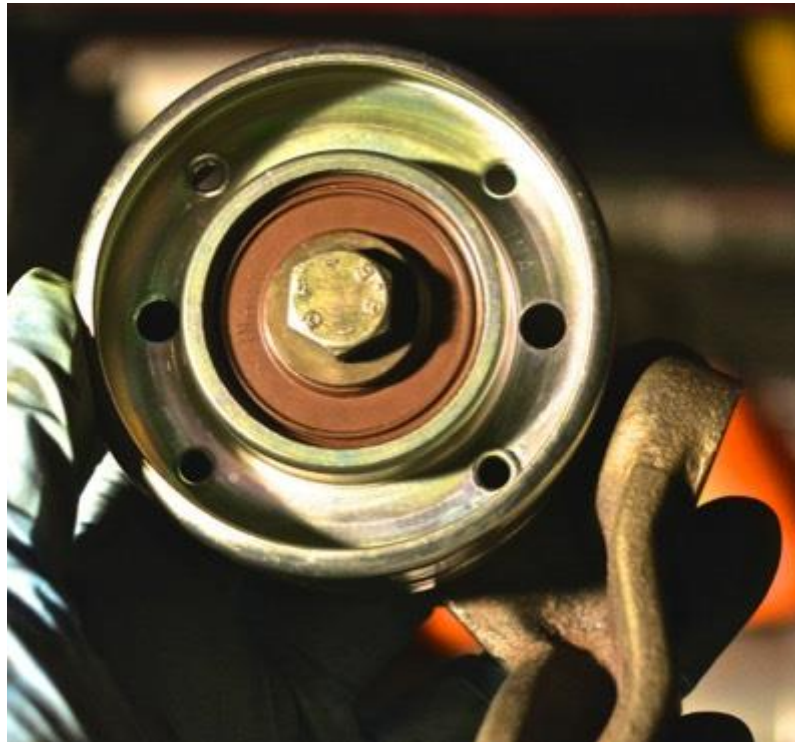
What did that do? Well, when I installed the tensioner arm, it was touching the upper idler roller, so when I tightened the bolt that goes into the upper idler roller boss, the upper idler

roller stopped moving. Yikes.

Here is the roller [928 105 512 12] on the tensioner arm. I installed new tensioner arm bushings as well. 928 105 613 04.

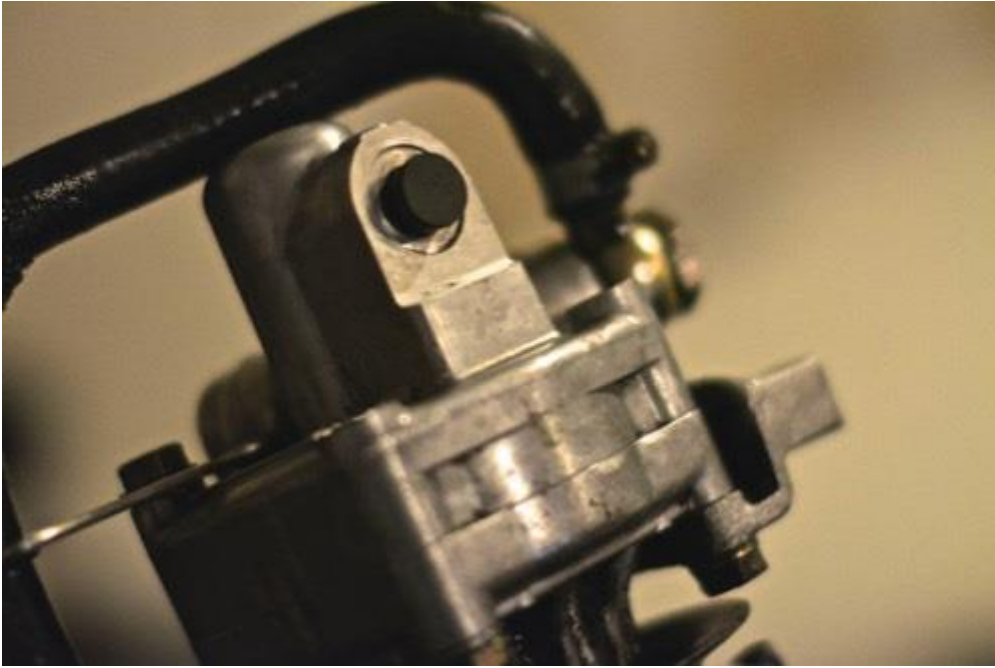
I had a big power steering fluid leak on the driver's side of the engine compartment, and this time I was going to fix it once-and-for-all.

First, I removed the power steering pump, and cleaned it.

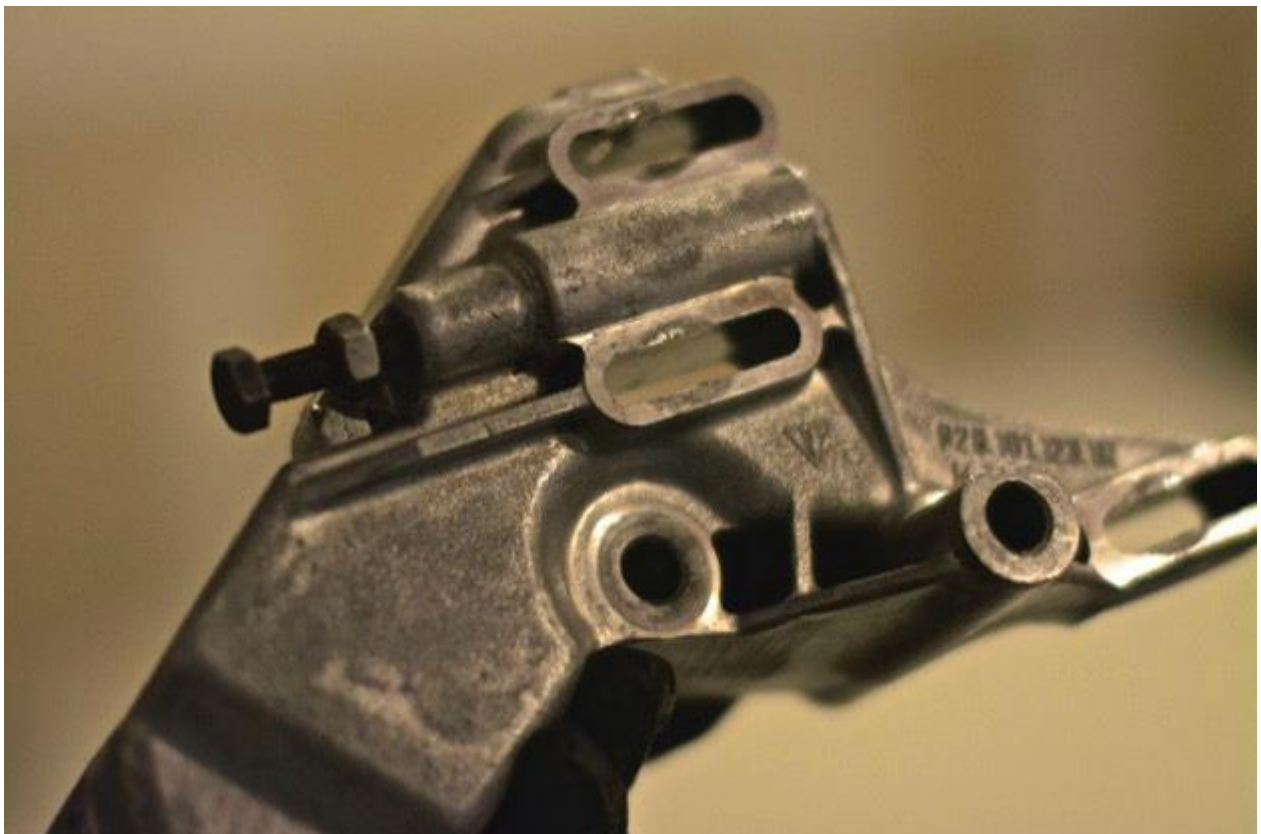
Then, I removed the power steering/alternator "cassette", and cleaned it. (It was so heavily encrusted in grease, I couldn't make out a shape.)

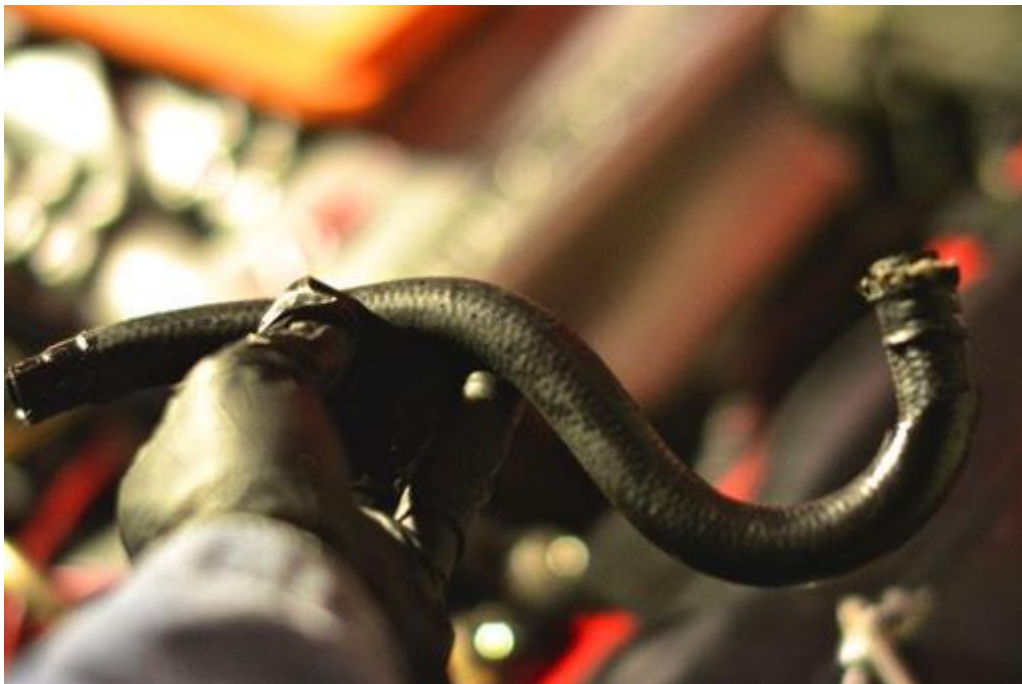
Once you get the crimped end off, you can pull off the short rubber hose that leads to the power steering reservoir. My old hose leaked.
