Using the 9131-944 Belt Tensioning Tool

Introduction: this short document contains a step-by-step guide for using the 9131-944 belt tensioning tool manufactured by ArnnWorx Specialty Tools. This tool is designed to assist with the tensioning of both the cam belt and balance belt on the Porsche 944.

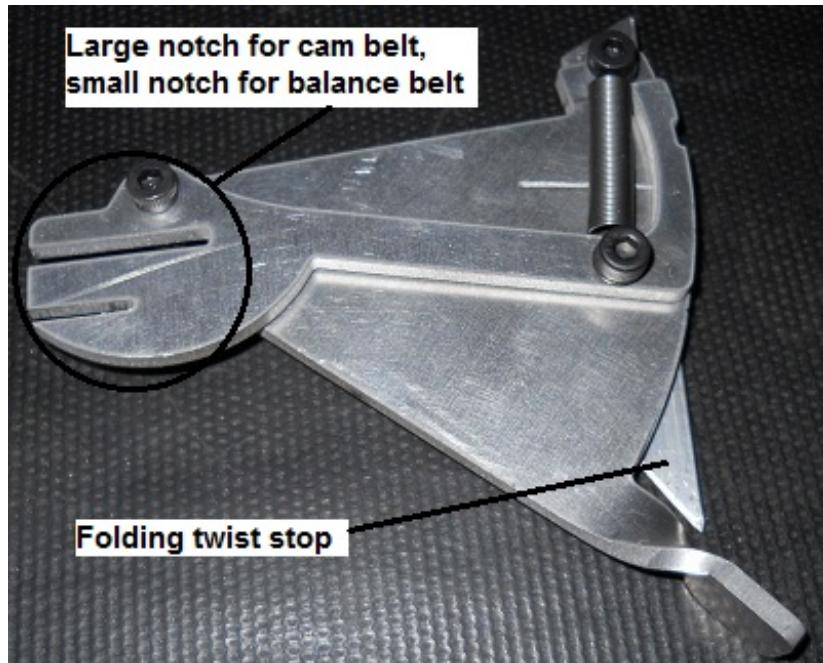
What is the 9131-944?

The 9131-944 is a tensioning tool derived from a Porsche tool, the P9131. The P9131 was prescribed for the early model years of the Porsche 928. It was later discontinued in favor of the expensive P9201. We have adapted and extended the original P9131 design for use on the 944 and provided an alternative way to check belt tension. The tool is a simple approach to a difficult problem - measuring the tension of the 944's cam and balance belts. To do this the tool must be precisely positioned on the belt and light finger pressure used to twist the belt. The belt resists the twisting pressure and a scale measures the resistance. A fold-away arm is used as a twisting stop.

1. Ensure the twist stop arm is extended as seen in the image at the top of this document. The angle of the arm is not critical; a final positioning of it will be done just prior to the reading.
2. Insert the tool onto the 5th open belt notch (count left from the upper balance belt cog). Be sure to use the small notch of the tool.

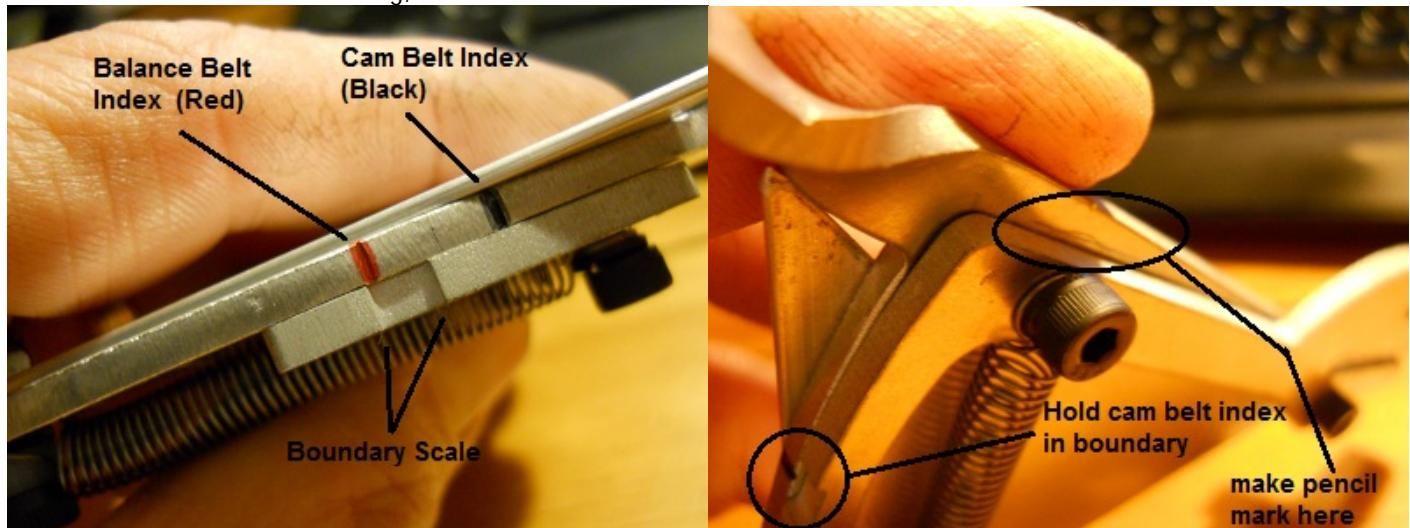
The 9131-944 is uses colored index marks together with a moving boundary scale. Reading the scale is simple, when the index is within the boundary, the belt is tensioned correctly. Refer to the image below - the left edge of the boundary scale notch represents the maximum acceptable boundary and the right is the minimum. For new cam belts, the maximum is the ideal setting, for used cam belts the minimum is ideal.

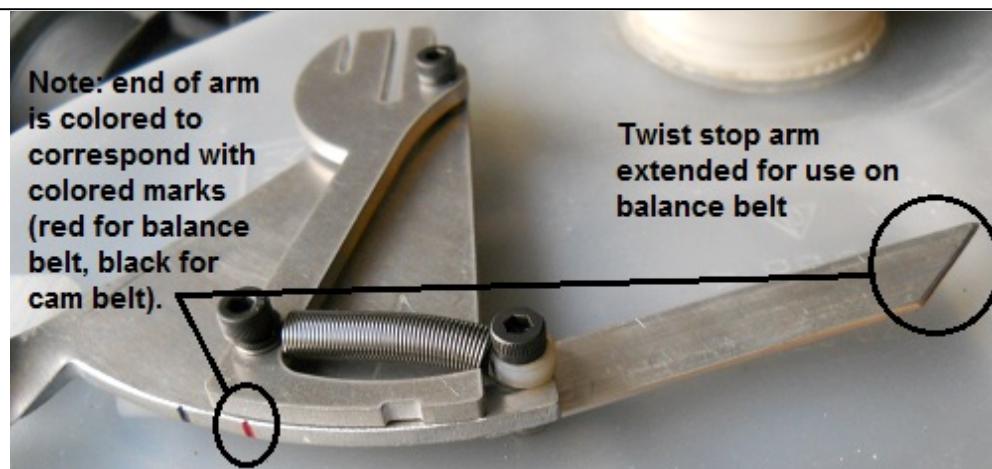
There is only a very small area along the lower span of the cam belt where the 9131-944 tool can work. When in that position, the scale is difficult to see. So, we transfer the boundary scale marks to a viewable place on the tool. These are very lightly scribed; you may wish to darken these marks with a pencil.

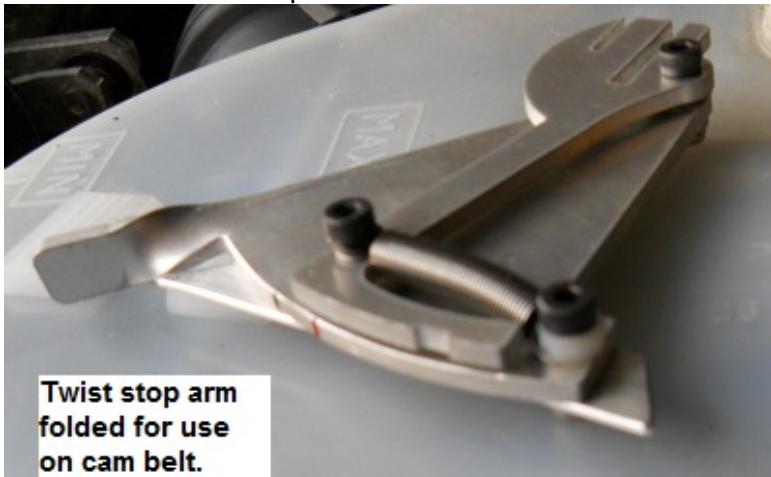
2. Ensure the twist stop arm is folded as shown below.

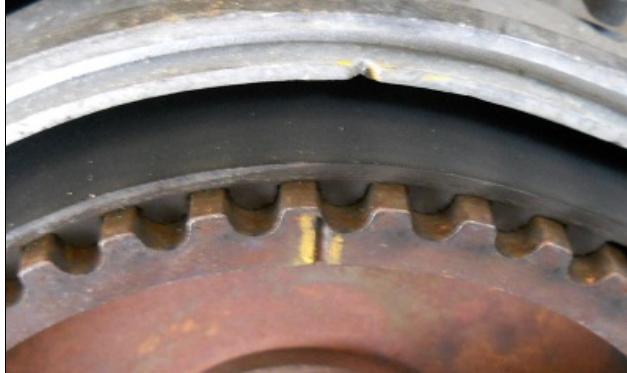
4. Using a 24mm socket, rotate the crankshaft and cam until the cam is 1 tooth left of Top Dead Center.

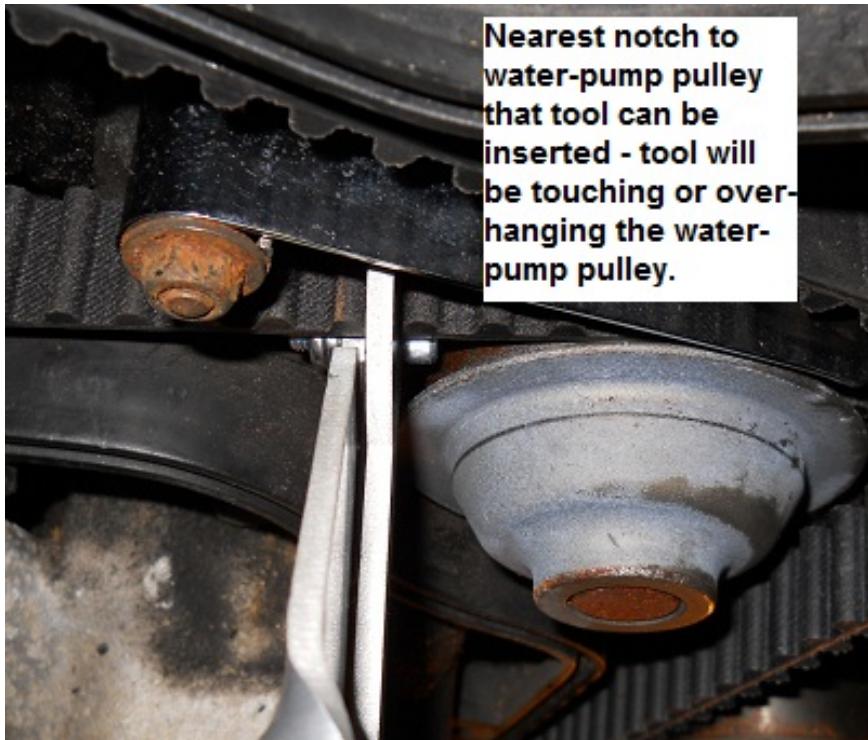
5. Place the tool on the cam belt notch, as near to the water-pump pulley as is possible. At this point, the 9131-944 tool may be touching the water-pump pulley.

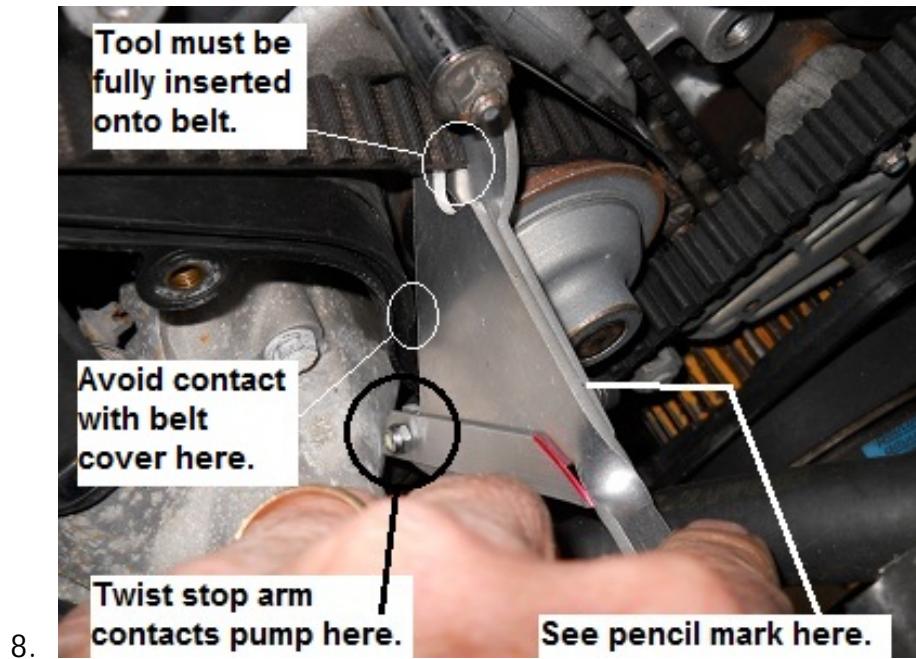
6. While observing the 9131-944, slowly rotate the crankshaft clockwise (approximately $\frac{1}{2}$ tooth). This will cause the 9131-944 to move away from the water-pump pulley. Stop as soon as the tool is clear of the pulley. In this location the tool can be rotated downward without touching either the belt cover or the water-pump pulley. Also, the clockwise rotation of the crank shifts the belt's slack to the lower belt span (where the tool is located).
7. Gently press down on the tool until the twist stop arm contacts the water-pump. With the arm lightly touching the pump, read the scale (or pencil mark). No belt adjustment is needed if the black mark is within the boundary scale. If an adjustment is needed, then it is best to make the adjustment and then repeat steps 4 through 7.

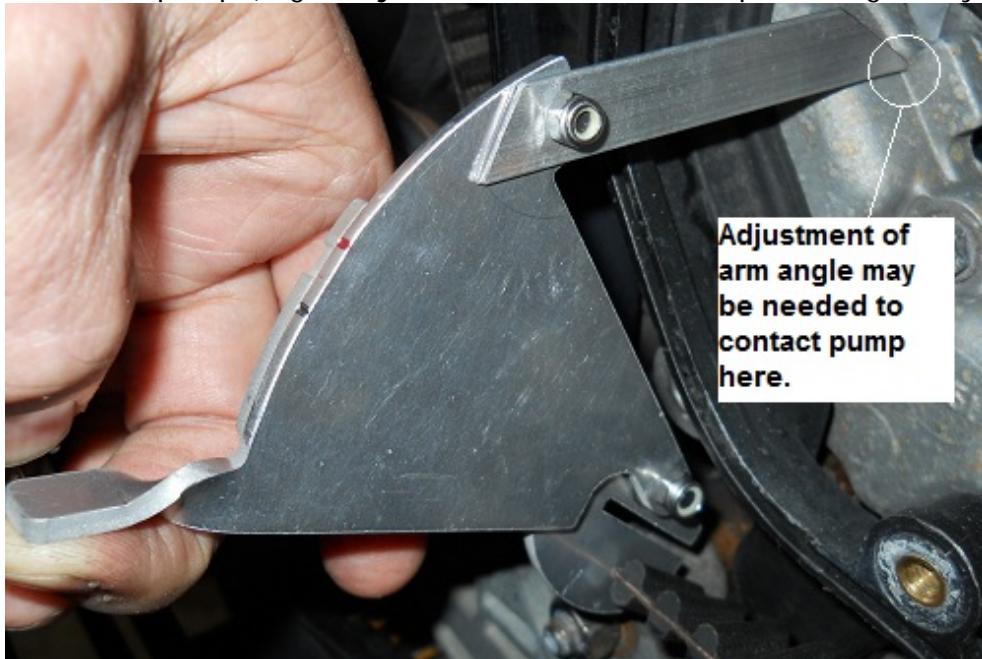
3. Gently press upward on the 9131-944 tool until the twist stop arm contacts the flange of the water-pump (slight adjustment of the twist stop arm angle may be needed).

4. Hold the tool in this position (lightly touching the water-pump) and read the scale. No belt adjustment is needed if the red mark is within the boundary scale. If an adjustment is needed, then it is best to rotate the engine 360 degrees following the adjustment to distribute the belt's tension evenly.
