**Provent filters:**

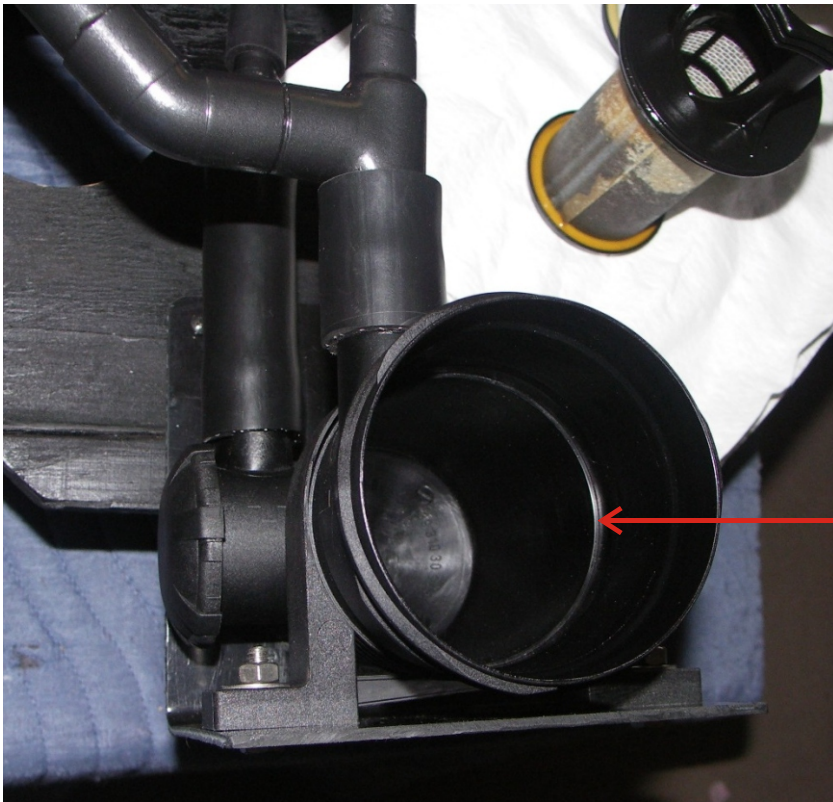
On the left you can see a filter that was inspected after 3000 miles it shows the level of oil that at times was accumulated inside the filter.

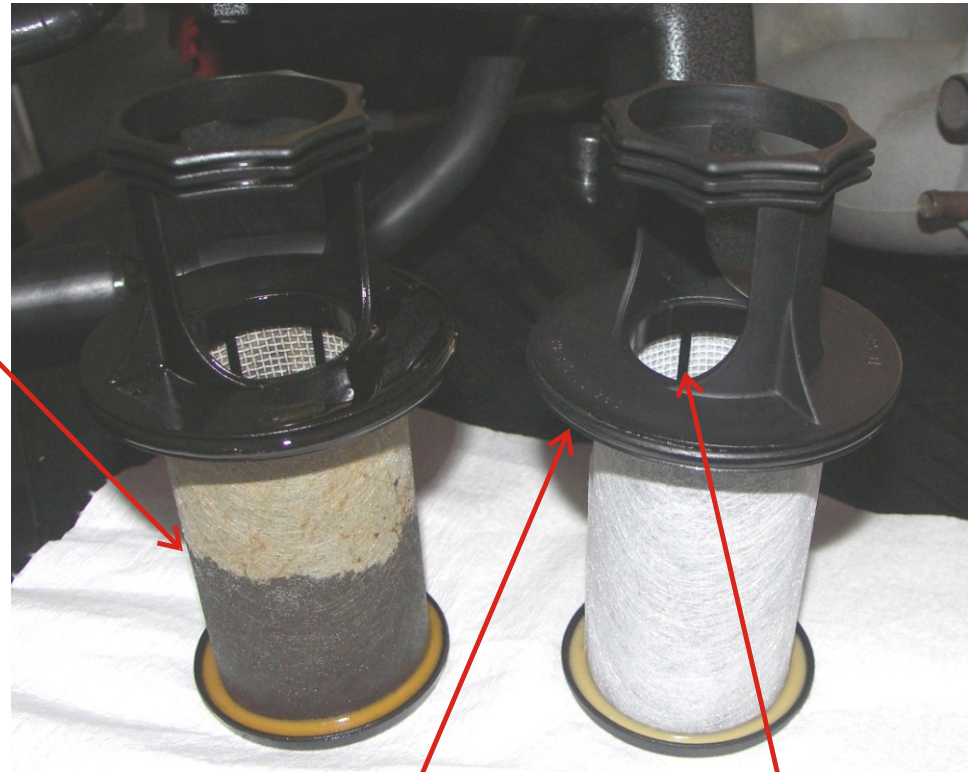
The filter on the right is a new filter element.

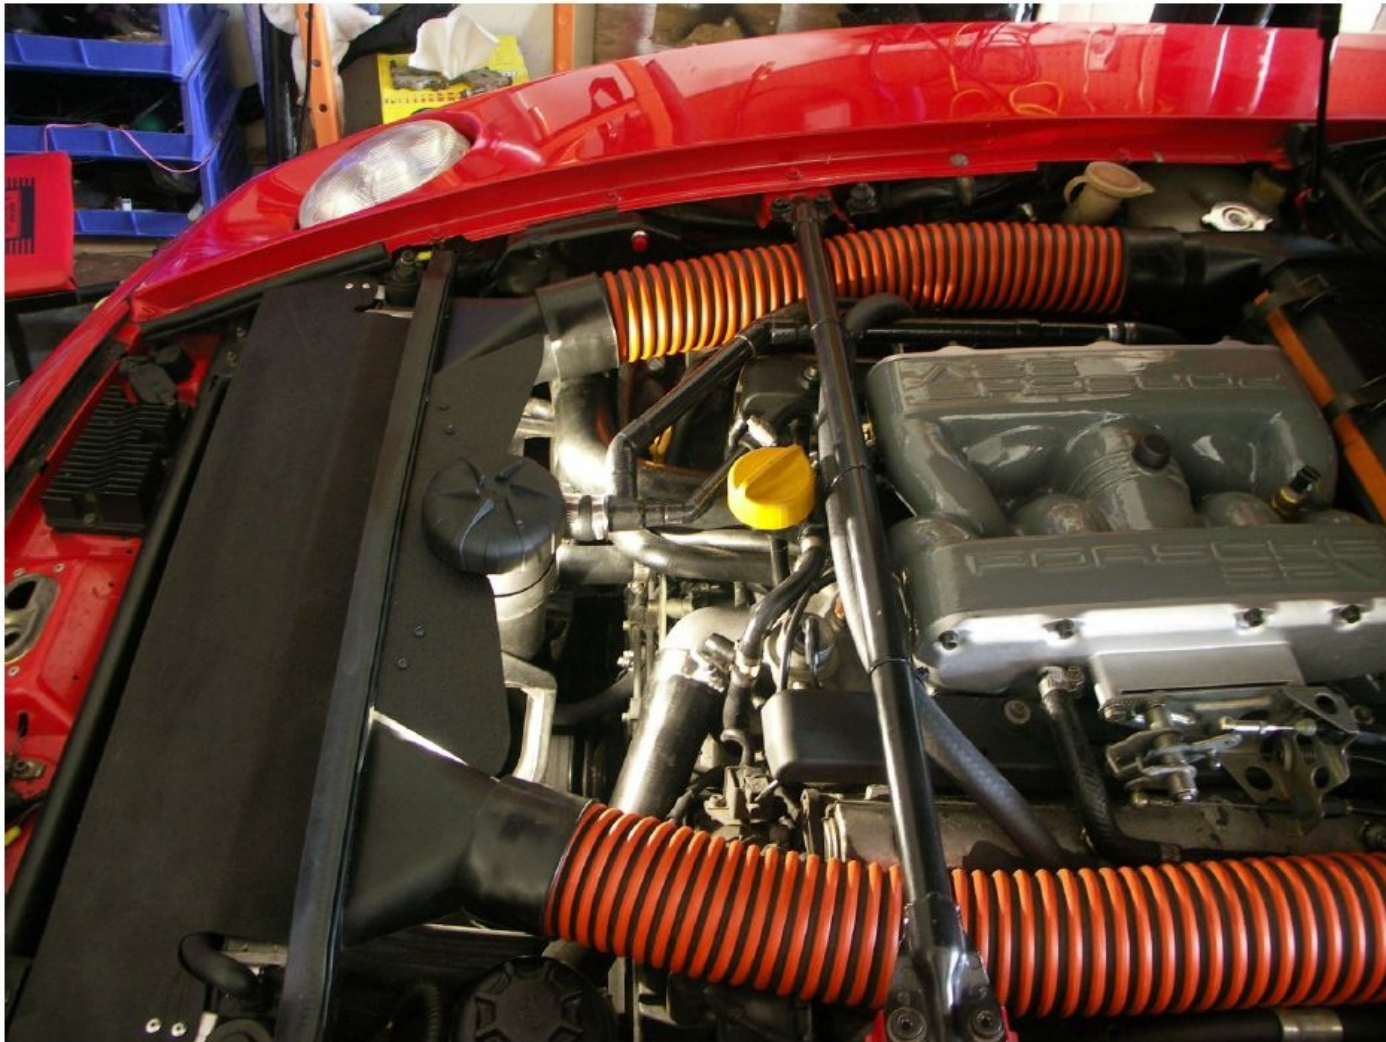
View of the Provent canister the filter "O-ring" seals on the ridge inside the canister and oil enters the filter through the opening in the center.
